# A Basic Building Survey and Archaeological Evaluation of a Blackhouse at No 28 Lemreway Isle of Lewis

**AUGUST 2019**

Authored by  
Ian Mchardy BSc (Hons), AIFA.

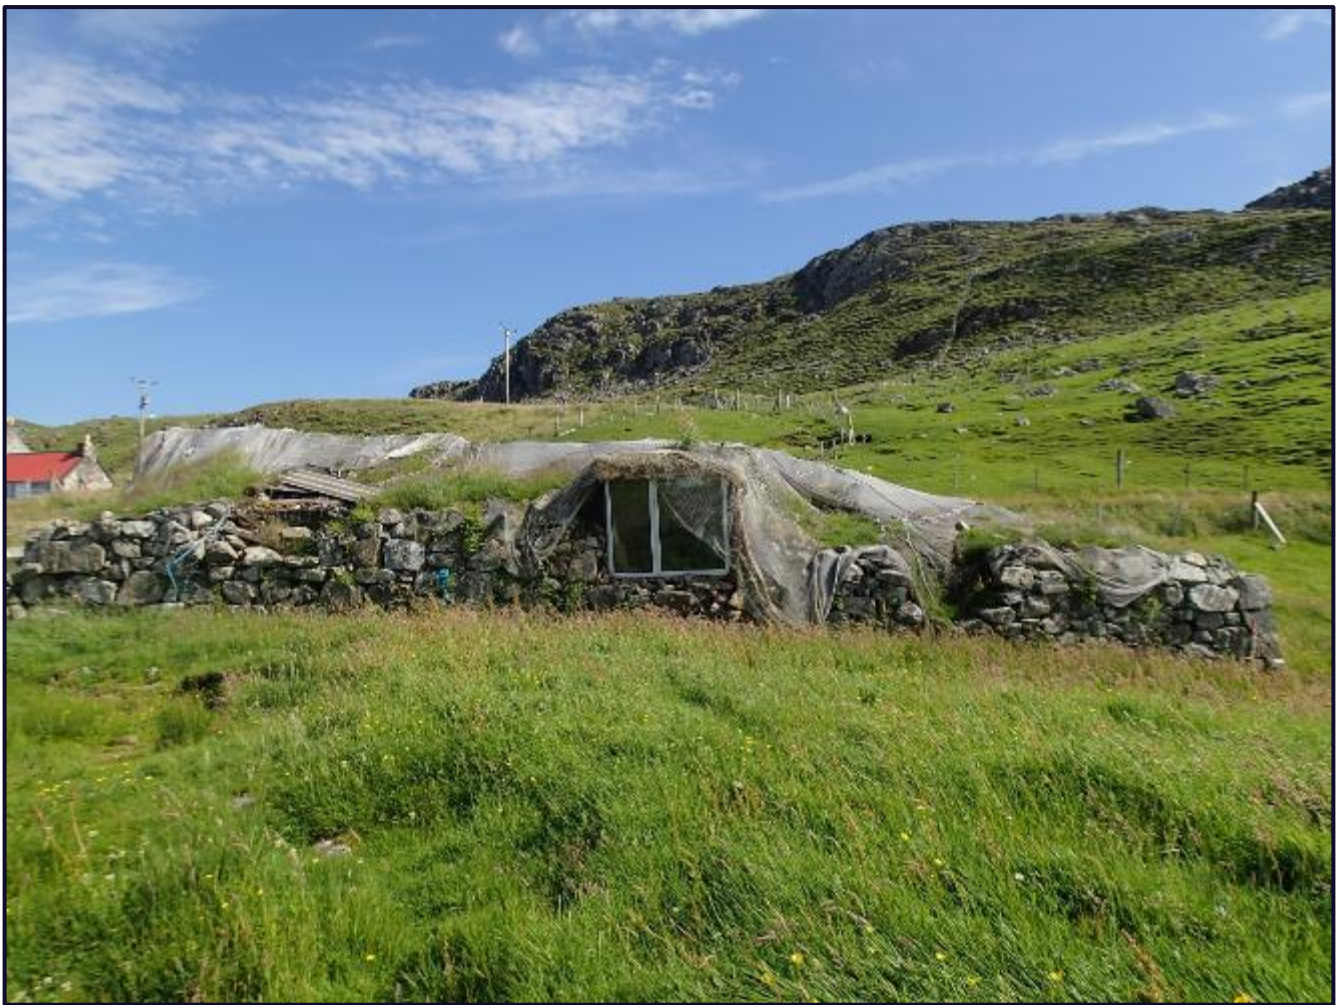
*Figure 7: South facing side of the Blackhouse at No.28, with slight rise or ridge of land coming towards the viewer and bottom right hand side - indicating position of the original Blackhouse.*

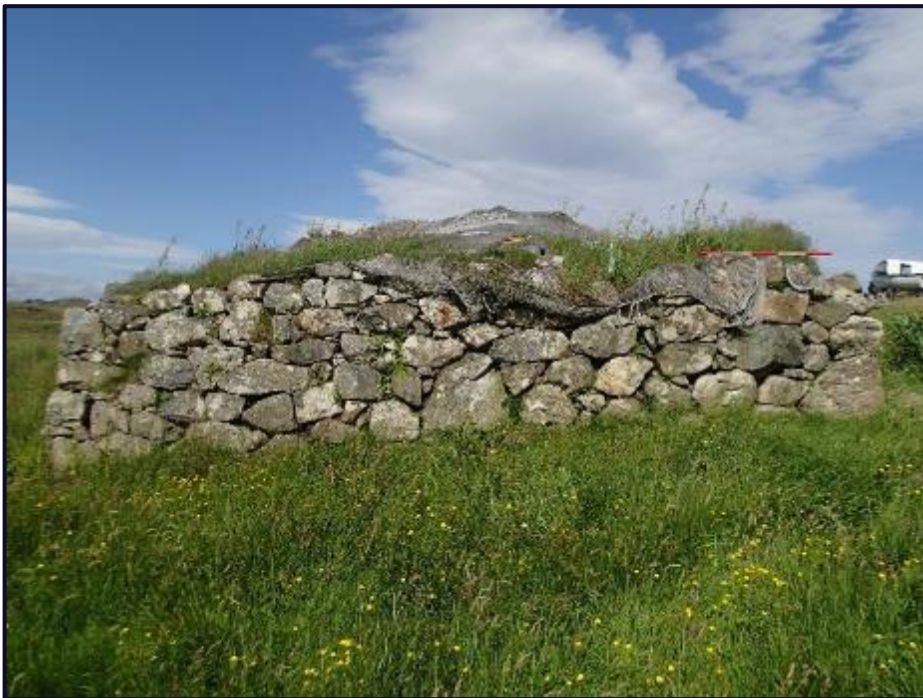
**Figure 11: East Gable. The large stone in the centre is a lintel for the drain.**

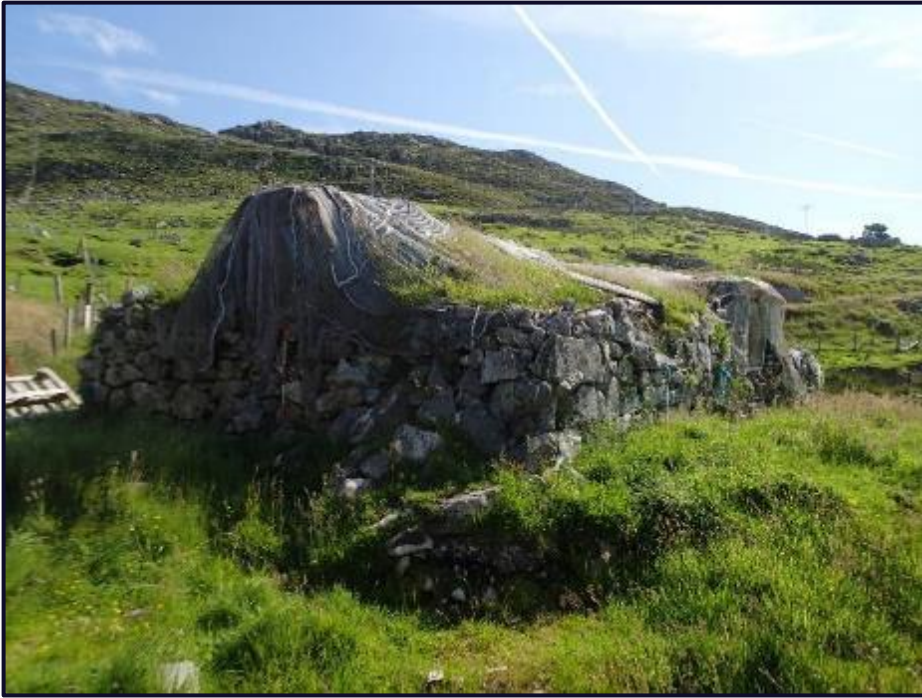
The blackhouse at No 28 Lemreway looks fairly typical at first. It is 15.80m long by 6.9m wide, built from mostly un-coursed, or very roughly coursed, un-dressed Gneiss blocks built up as interior and exterior faces of a 1.2 – 1.6m thick wall. The walls seem less well built than other examples nearby. The wall heads seem to have been robbed of stone and vary in height quite considerably around the building, from 1m to almost 2m, leading to the inference that the original clay capping may have also been damaged in places. The western Gable has collapsed outward, as has some of the south wall.

*Figure 14: SW corner and Gable*

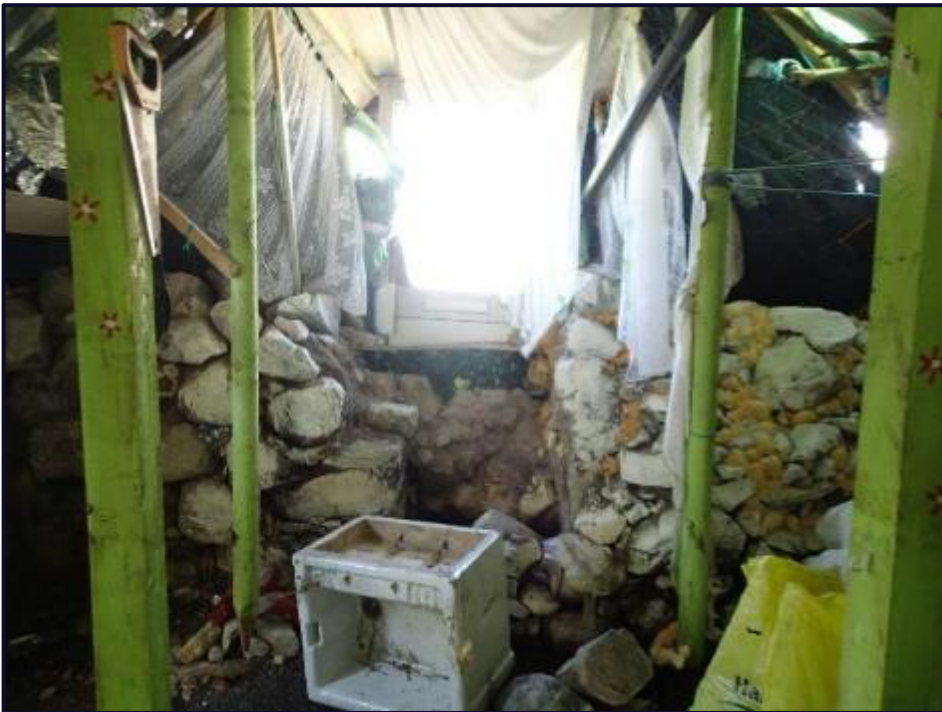
*Figure 23: Hobble of fireplace built into west Gable, mostly collapsed*

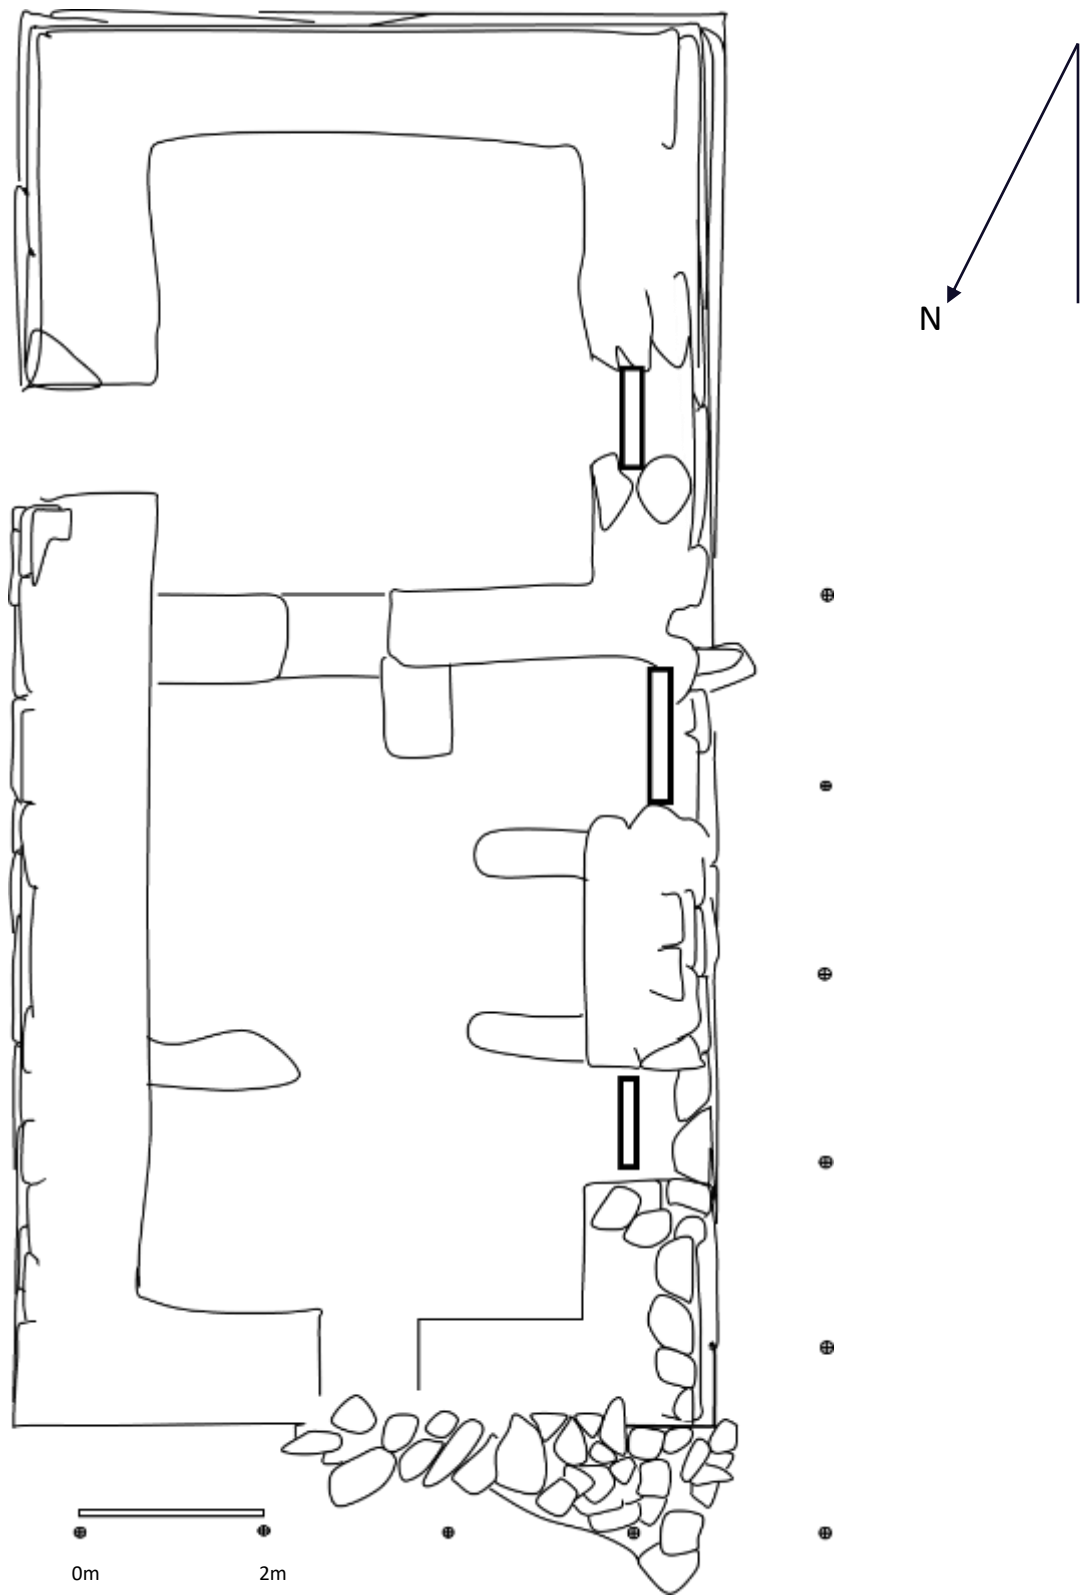
**Figure 25: Scale plan of Blackhouse**

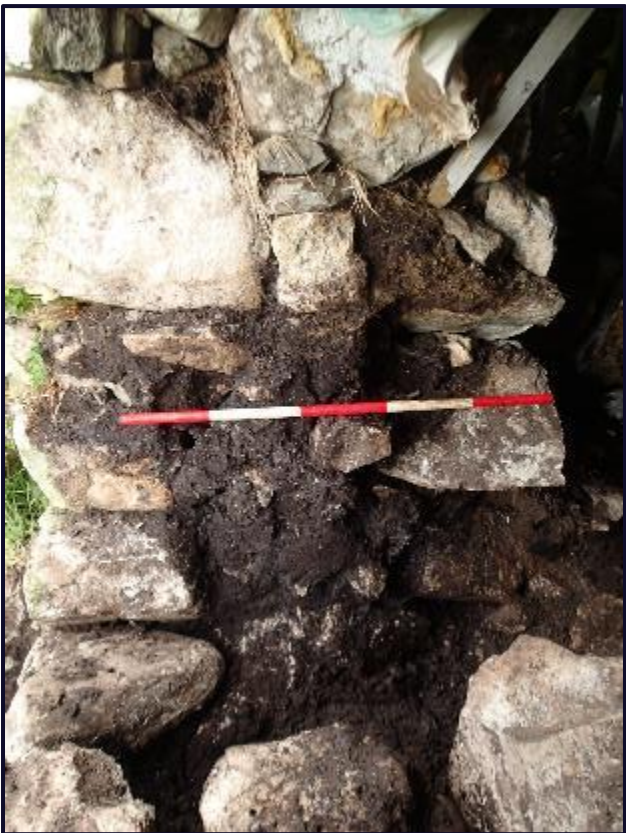
The section of wall to be taken down was directly under the middle window. At first the blocks were loose and surrounded by modern detritus but as these were cleared away it became clear that there was an original built-in Ingo for a window at this point in the wall. Just under the main stones of the Ingo the first in-situ deposit encountered was a small area of yellow clay (004) which capped a wall fill of dark peaty soil (005), possibly as part of the window's cill. The stones of the interior (006) and exterior (007) walls were taken down and the wall fill (005) between them as they went, excavating by hand. A small graphite pencil was discovered within the wall fill – Figure 29, below - as well as various 19<sup>th</sup> century ceramic sherds. The foundation course for the walls was underneath the level of the modern day soil surface, and this lower 0.3m section of wall appeared to have no batter – see Figure 30, East facing section of trench, below.

The wall rested partly upon outcropping bedrock, and partly upon a densely packed layer of stones, each around 2-400mm in any dimension, termed 008. This layer carried on under the whole width of the building, and c.05m outside of it. It is a common feature of blackhouses, allowing water to drain under the clay capped floor. Under this was 009, the natural subsoil. It was a gritty sandy, densely compact, orangey-brown clay. The foundation deposit 008 was not removed from the whole width of the trench and so we cannot be absolutely sure that it was the same thickness all the way across, although given the ground levels each side it seems likely. It was not fully excavated because it was not considered important to do so once a small section had showed the sequence, and this deposit may ultimately be useful as a foundation for the new redevelopment, and would have undermined the walls if removed.

**Figure 30: Cross section of wall mid-excavation**

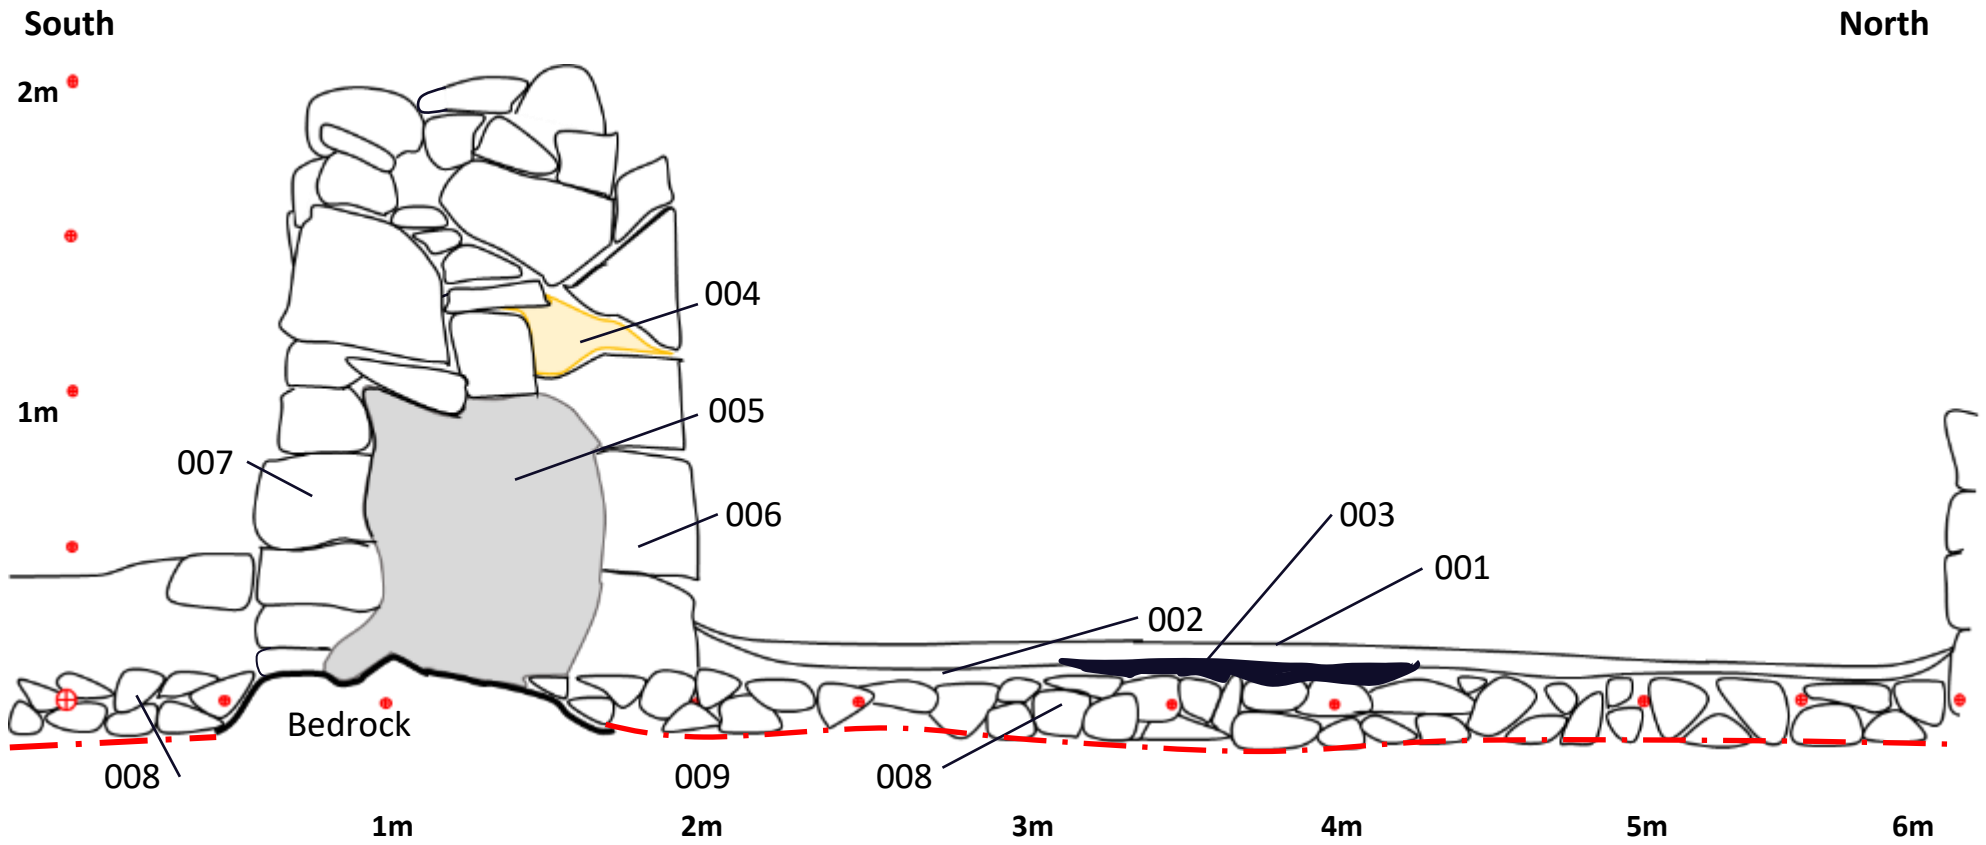
Figure 31: East facing section of Trench 1, across wall and floor

Here, the clay floor (002) is laid after the walls have gone up, and is laid up against them (see Photo 77). At 9A Grimshader the clay floor was laid the same way. So the construction sequence revealed is - remove all top soils from the footprint of the house, down to the natural sub soil (Drains were also probably cut into this sub soil), add a thick foundation layer of compacted stones, then build your walls adding the fill as the wall faces are built. Then finish with the clay floor.
