No. 1, Geshader, Uig:
A Standing Building Survey.

By Ian McHardy, B(Sc) Hons,
Associate of the Institute of Field Archaeologists,
70 Seaforth Road Stornoway HS1 2SD
irmchardy@gmail.com

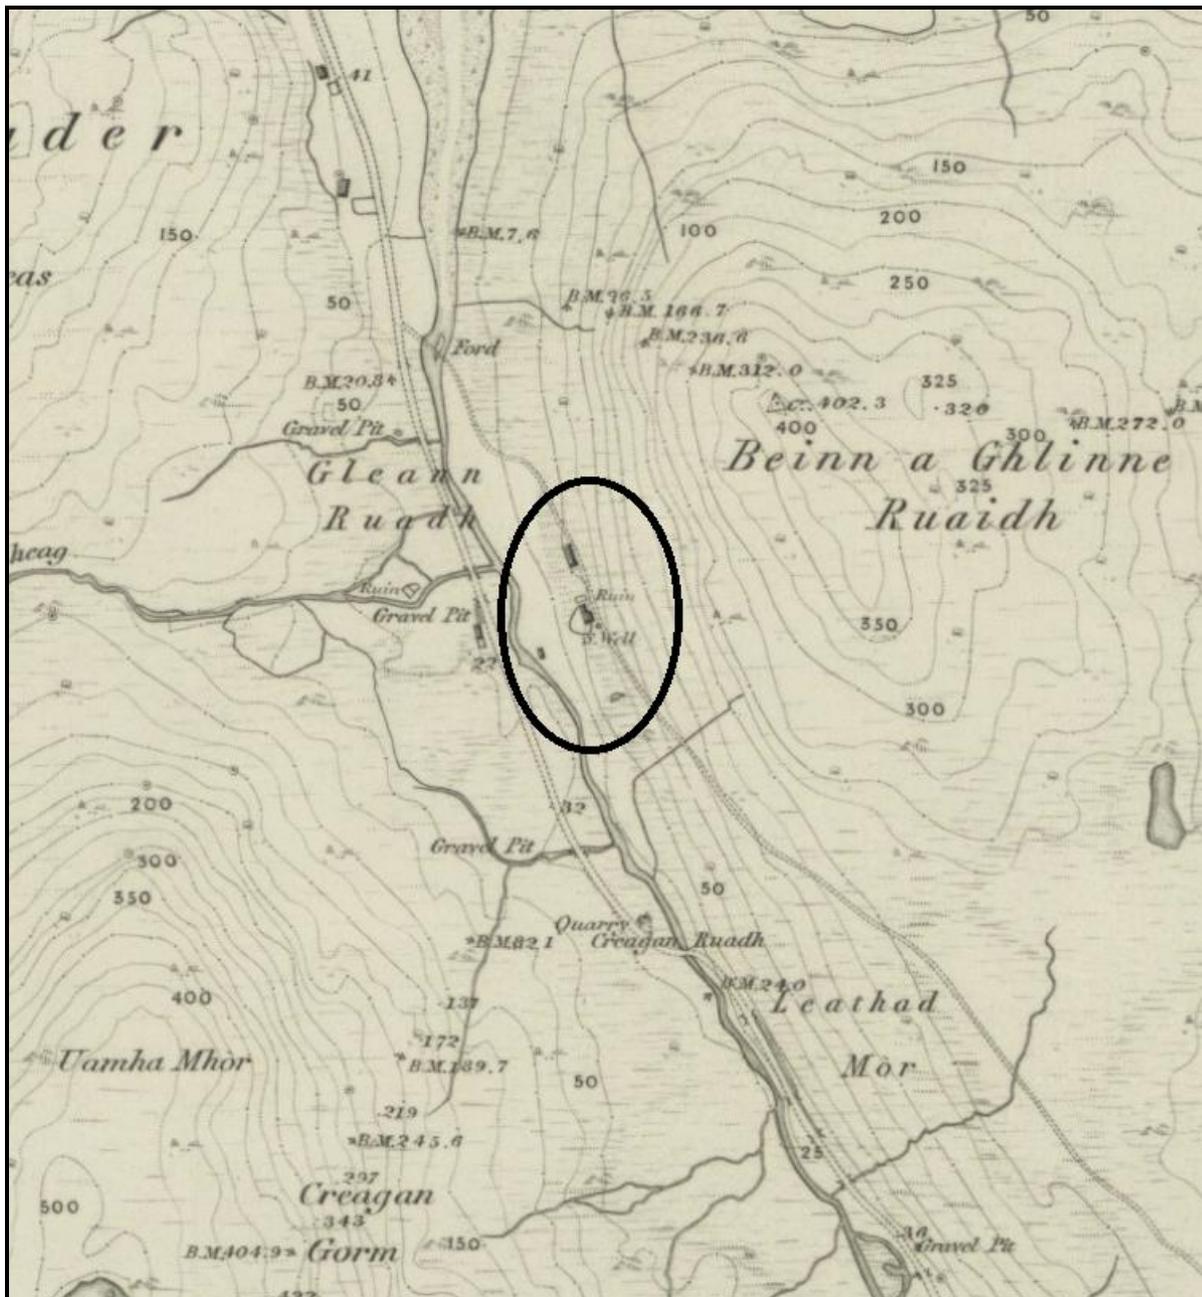
Figure 3: 1st edition; detail of house, marked “Ruin” and “Well” on the track ascending “Leathad Mor”.

However the building shown on the 1st edition looks more like a “White house”. White houses – loosely defined - were built of rubble stone and mortar, had a roof of slate, tiles or tin with chimneys in the gables and commonly white washed. They started to appear in the Hebrides in the 19th century and are associated with the so called “Improvements” which swept the Isles in that century. Certainly they were cleaner than the average Blackhouse, which accommodated cattle as well as humans and often had an open sewer for both. However not everyone saw them as an improvement, the Blackhouses being much warmer for one thing.

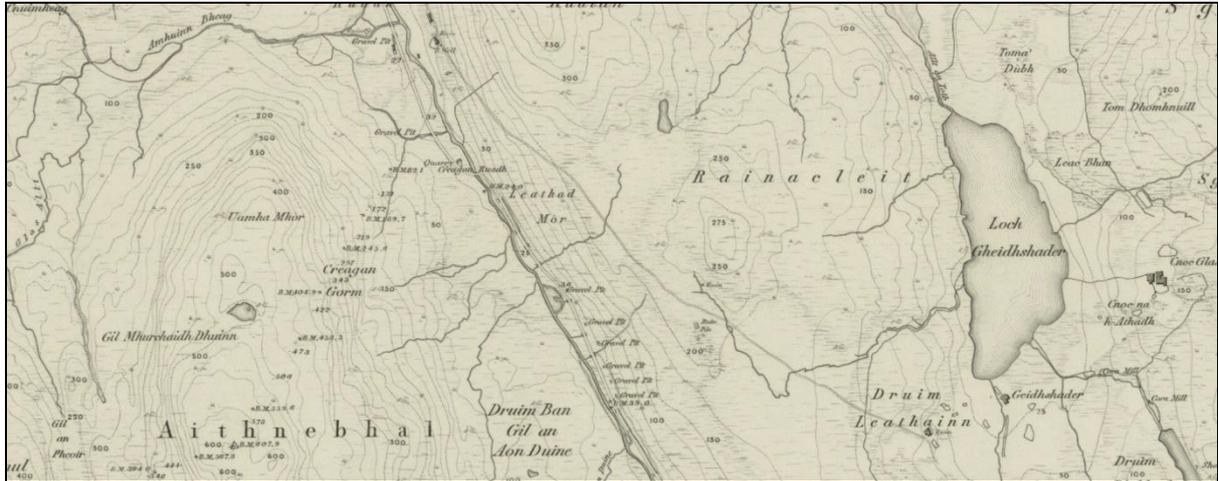
Figure 4: The bigger house at the end of the road to Druim Leathainn. Note the even bigger houses in Geisiader.

Further evidence that No 1 was part of a larger farm is the large Whitehouse at the end of the road that runs behind the house (see Fig 4). It would seem sensible to suggest that those at No 1 had some kind of relationship with these people, which might have been farmer and cotter, i.e. the house at No 1 may have been a tied house for a farm workers family. We might also include here the potential importance of No 1's location within the landscape in relation to other important resources: that the river had precious fish, and that there were no less than two thoroughfares metres from the door. There may have been responsibilities that went with living at No 1.

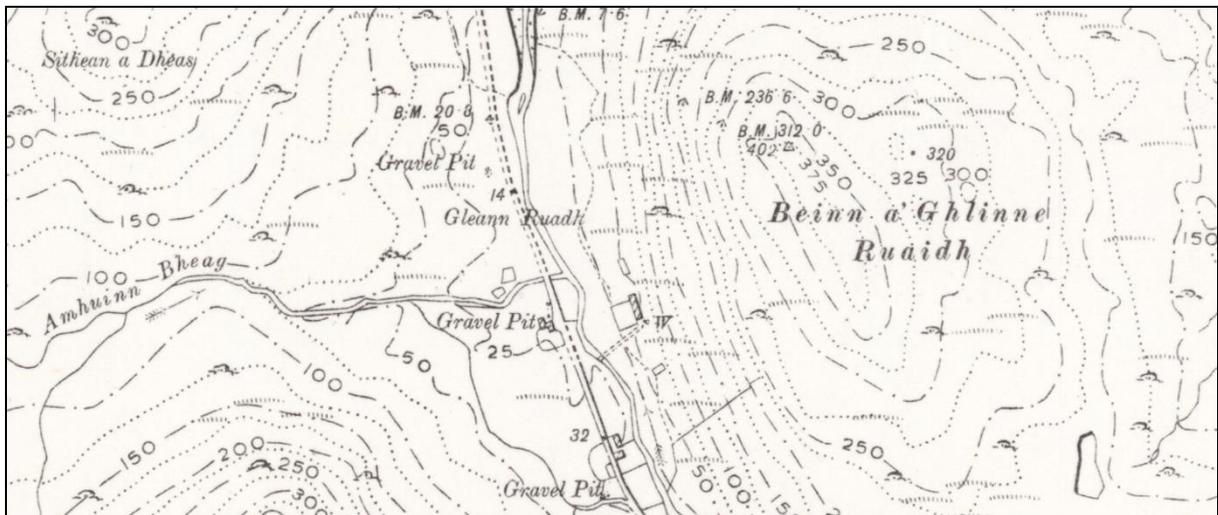
Figure 5: 1895 2nd edition OS map of the house. Note the track up the hill has disappeared, the house and garden enclosure have been enlarged and straightened up to resemble the structure we see today. A vertical boundary wall can be seen running down Beinn a Ghlinne Ruaidh – the edge of cultivated land perhaps?

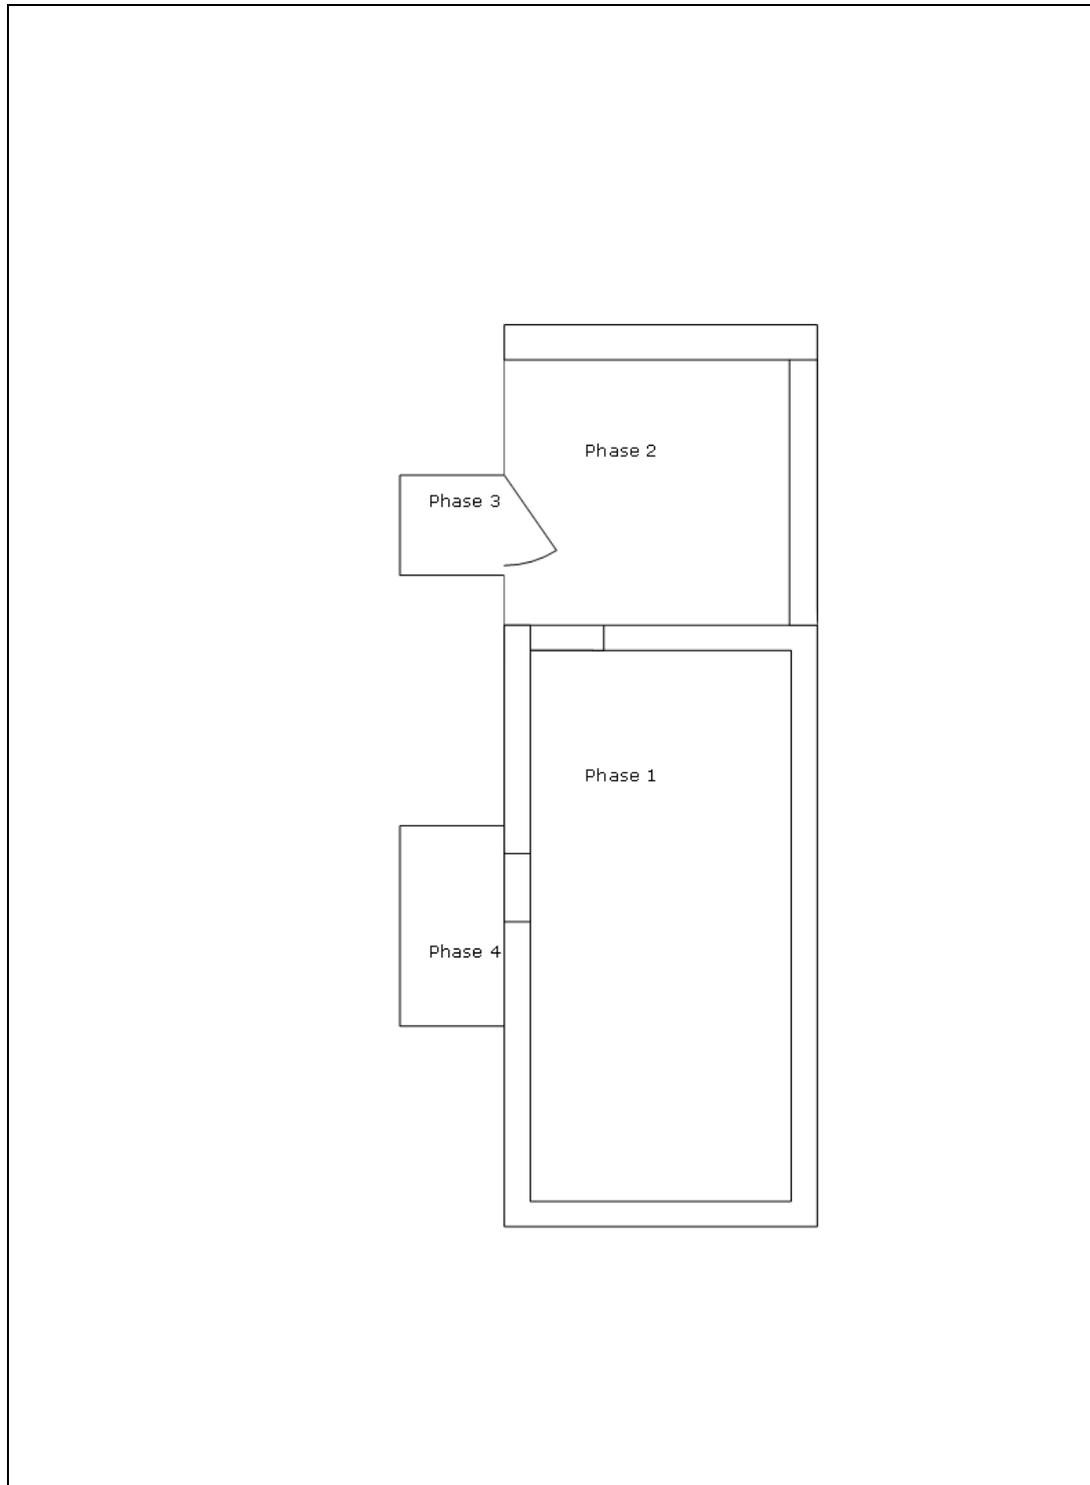
Figure 6: Phases of the building. North to top. Drawing approximately to scale but see figure 7 for plan to scale.

As noted the main, original structure (Phase 1), is constructed of large blocks of local Gneiss bonded with a shell lime mortar. A chimney was provided in both gables. We do not know what the original outer roofing material was, but the sarkin and trusses we see today may be the original. Certainly it can be seen in the loft that the windows in the roof space have been added after the sarkin was fully installed, as a drill has been used to cut through the boards (Photo 135c). At first there would have been a suspended wooden floor throughout this structure, however concrete floors were subsequently added to the northern rooms and the suspended floor now only remains in the southern room.

The northern extension represents Phase 2. As the whole building is harled it is not immediately obvious that this extension is a hotch-potch of different materials. The back (E) wall is poured concrete, only 150-200mm wide. The front (W) wall is of timber frame clad on the outside with fibre sheet (the same as now on the roof) – and then harled on top (Photos 023, 024). Inside it was covered in hardboard sheet and then wall-papered – as with the entire inside of the building except for the poured concrete wall (it is very hard to fix things into poured concrete). The new northern gable is however built much like the original structure with large Gneiss blocks and mortar. I could not see enough of the mortar to be sure (it was very degraded, dirty and dark) but it seems like the same shell lime mortar as used elsewhere - it had also turned powdery unlike modern cement. This room does however have a concrete floor. This may be contemporary with phase 2 or may have been added later. Whenever it was put in, it may have been at the same time as the suspended floor was taken out of most of the phase 1 structure and replaced by poured concrete, everywhere except for the southernmost room. This may have been designed to combat issues arising from the water pouring down off the hill above - Mr Iain McDonald related that there was/is an actual culvert taking water directly under the house. From the looks of the back of the house today it would seem this has blocked up.
