A Basic Building Survey and Archaeological Evaluation of  
a Black house at 9A Grimshader,  
Isle of Lewis.

By Ian McHardy, B(Sc) Hons,  
Associate of the Chartered Institute of Field Archaeologists (ACiFA)

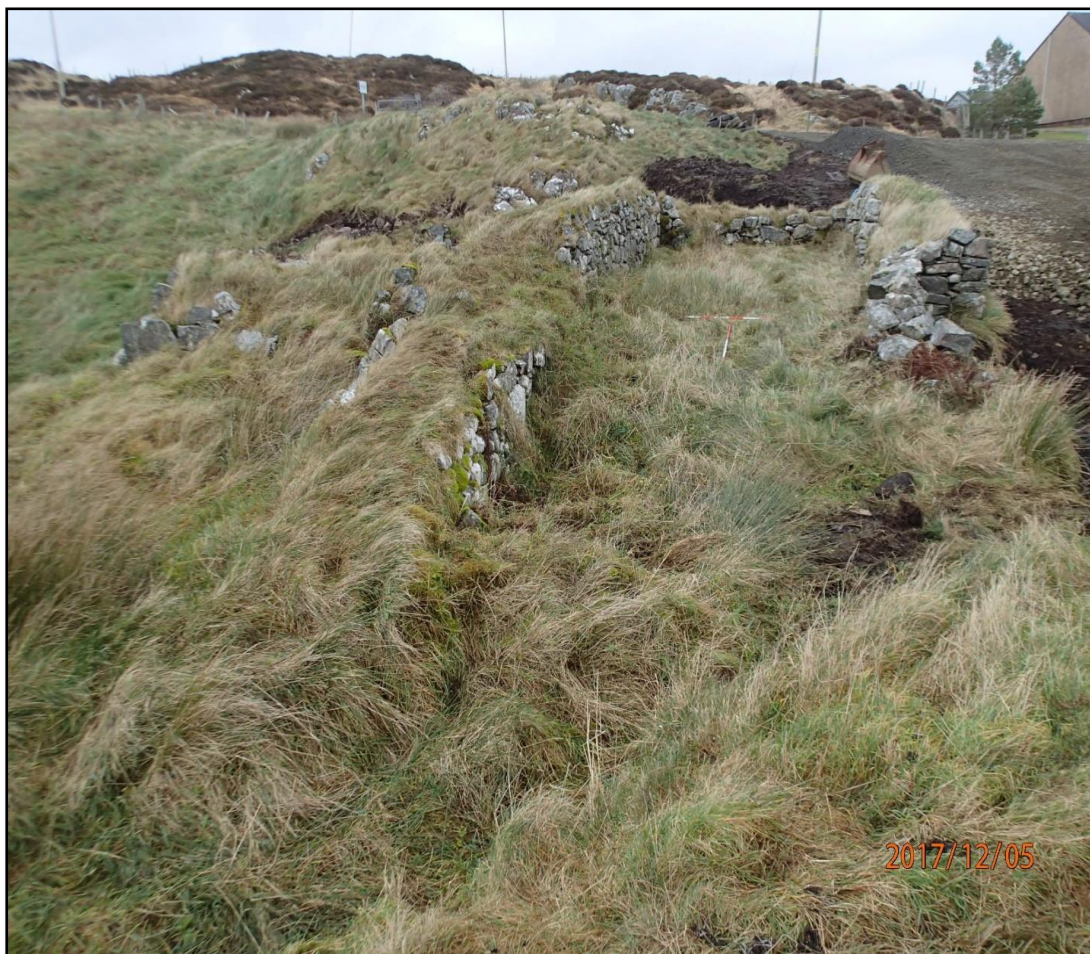
*Figure 8: Looking North at Blackhouse and Barn. New access road to the right.*

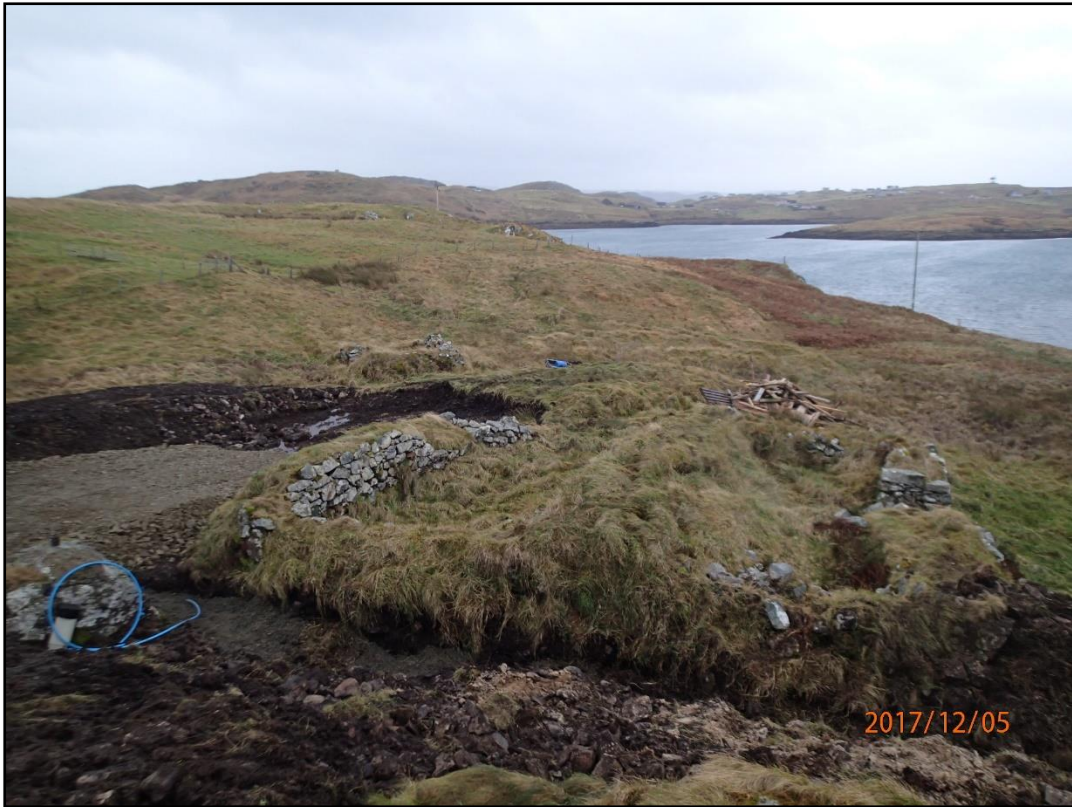
*Figure 9: Looking South at Blackhouse and Barn. New access road to the left hand side.*

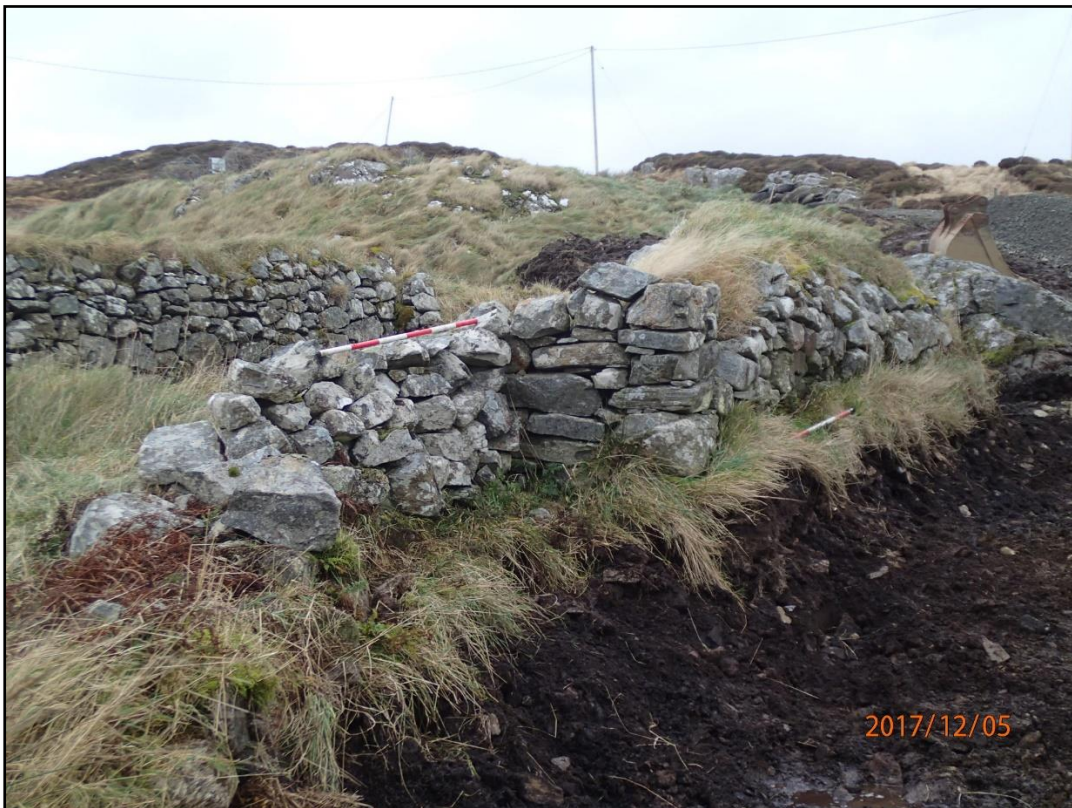
The southern, lower end of the Blackhouse had been robbed of a lot of stone so that all that was left of the southernmost wall was a low rise. The southeasterly section of wall (south of the main entrance) had also been completely robbed of stone at some point, before a very rough bit of wall was hastily re-erected in its place – see Figure 10. The north side of this entranceway remained standing to 6 courses. The rest of the walls were typical massive blackhouse walls, up to 1.5m width at base but with a batter leading to more slender upper sections of around 1.1m. They survived to almost 2m high in places. It was clear that internally the walls had been built with more care; the stones were coursed and fitted together better – see Figure 13, below. Outside the stones had no coursing and would be described as random rubble stone work – see Figure 12. One small section of the internal wall had been mortared together with concrete – see Figure 15. Interestingly, blue clay was also found in between stones of the internal walls and may have originally been used as plaster to cover the walls – Figure 16.

*Figure 10: East external wall showing North side of entranceway remaining with re-erected stock? wall to the left, under scale rod.*

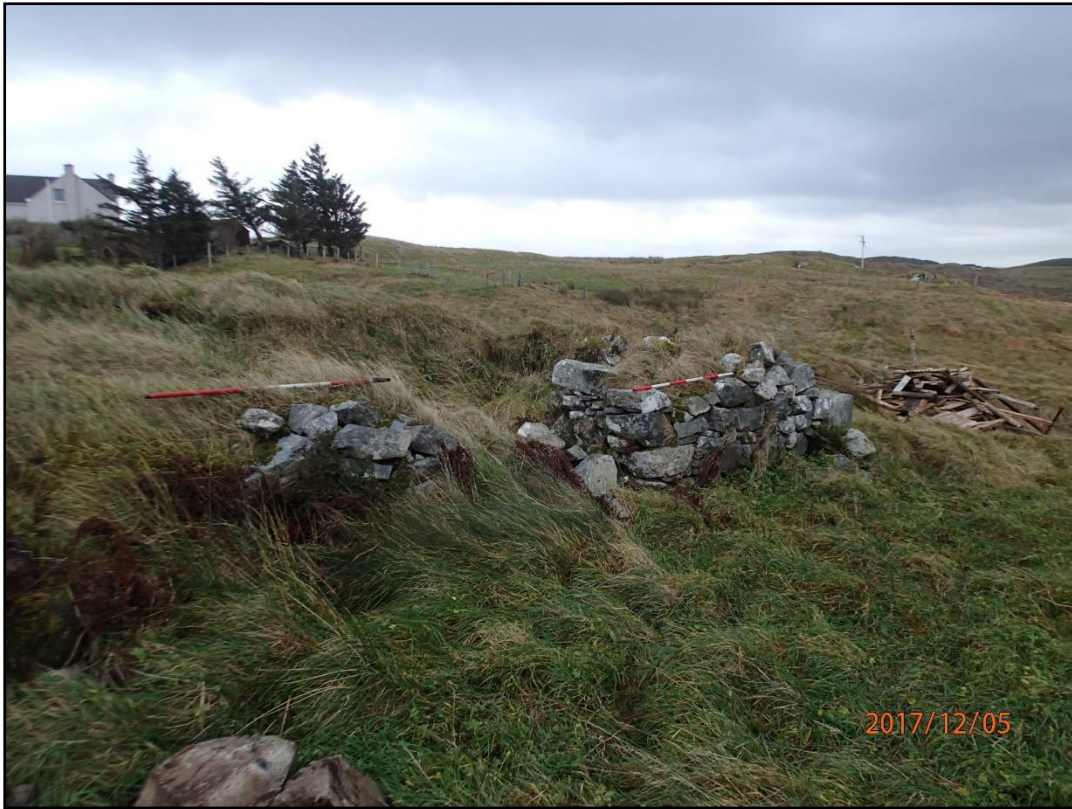
*Figure 11: Entrance to Barn on West side of Building.*

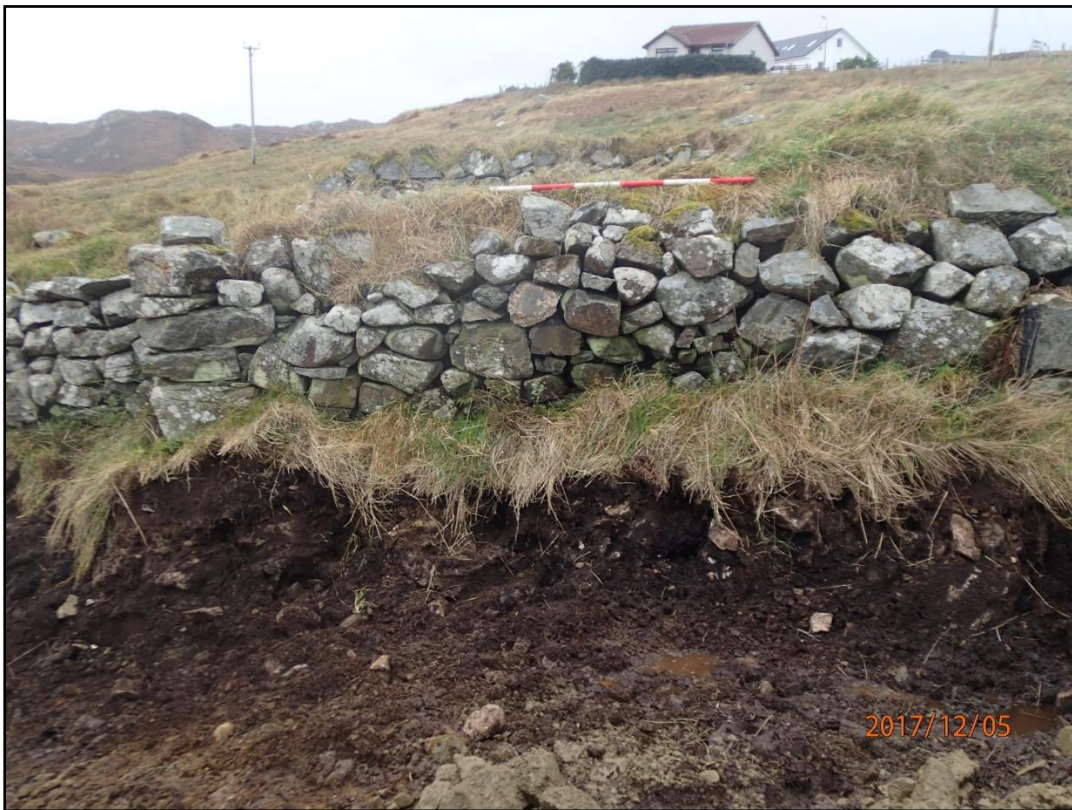
*Figure 12: Northeast external wall showing random coursing*

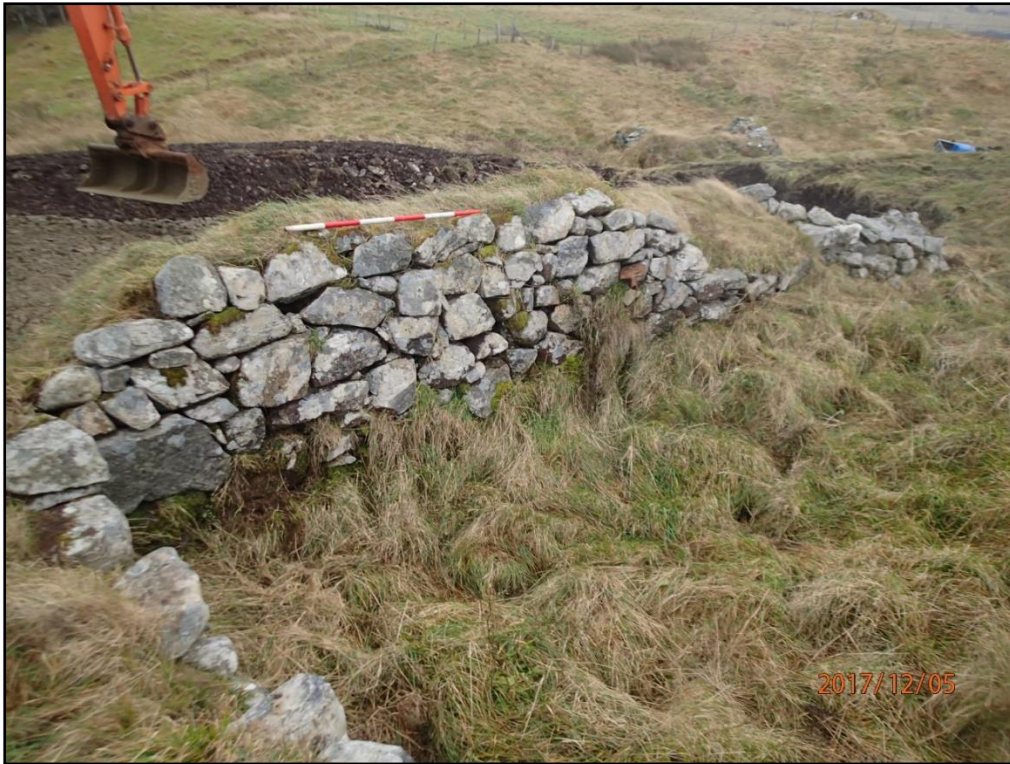
*Figure 13: Northeast internal wall showing coursing*

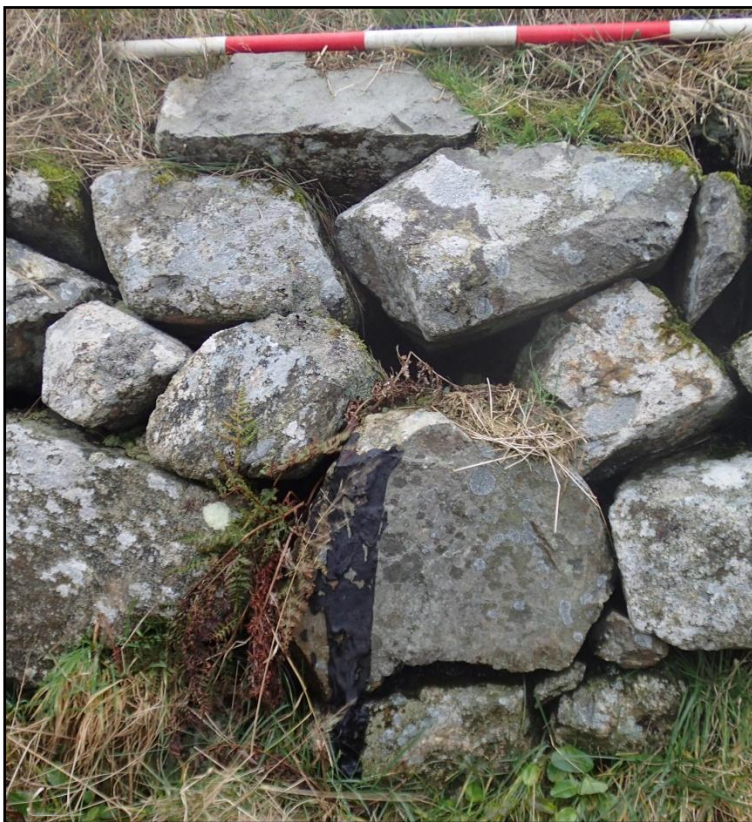
*Figure 14: Tar on North Eastern external wall (003), presumably from a time after thatching when the roof was “modernised”.*

We can also tell from the concrete and Lino flooring, as well as the Tar drip, that the Blackhouse went through numerous repairs and modernisations. Although I do not have an exact date, modern rubbish such as screw top bottles and a Whisky water jug found in the top soil above the floor indicate that the Blackhouse was probably inhabited from c1835 through to the mid-20<sup>th</sup> Century, or around 100 years.

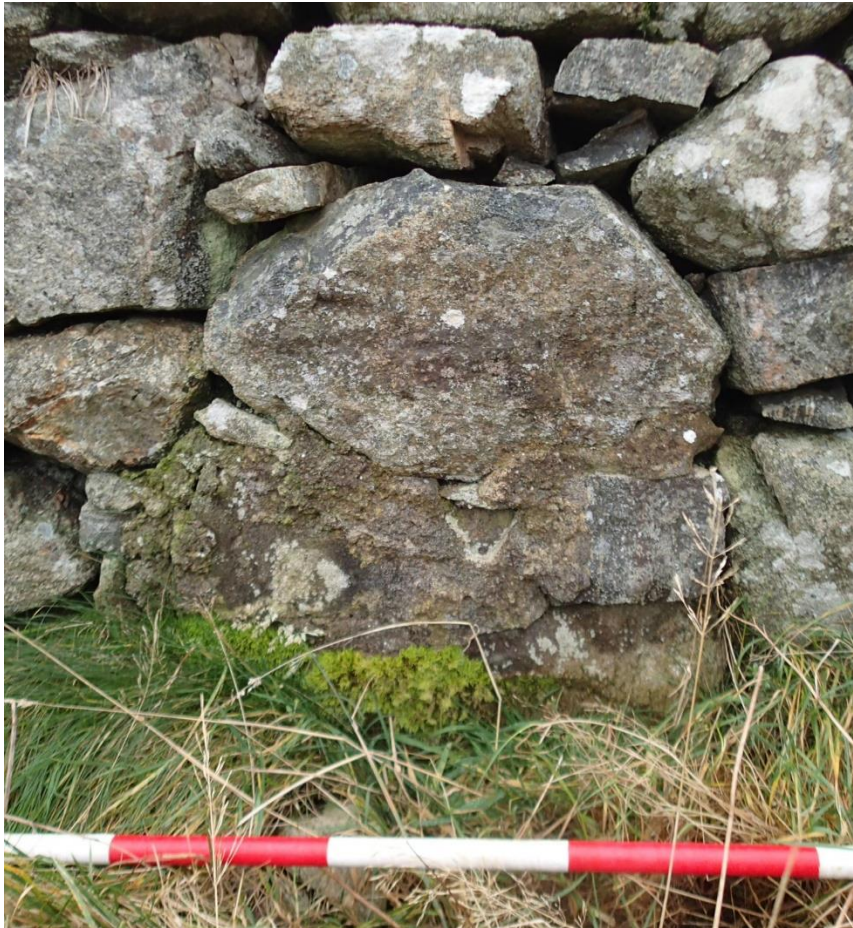
*Figure 15: Concrete pointing of section of internal wall*

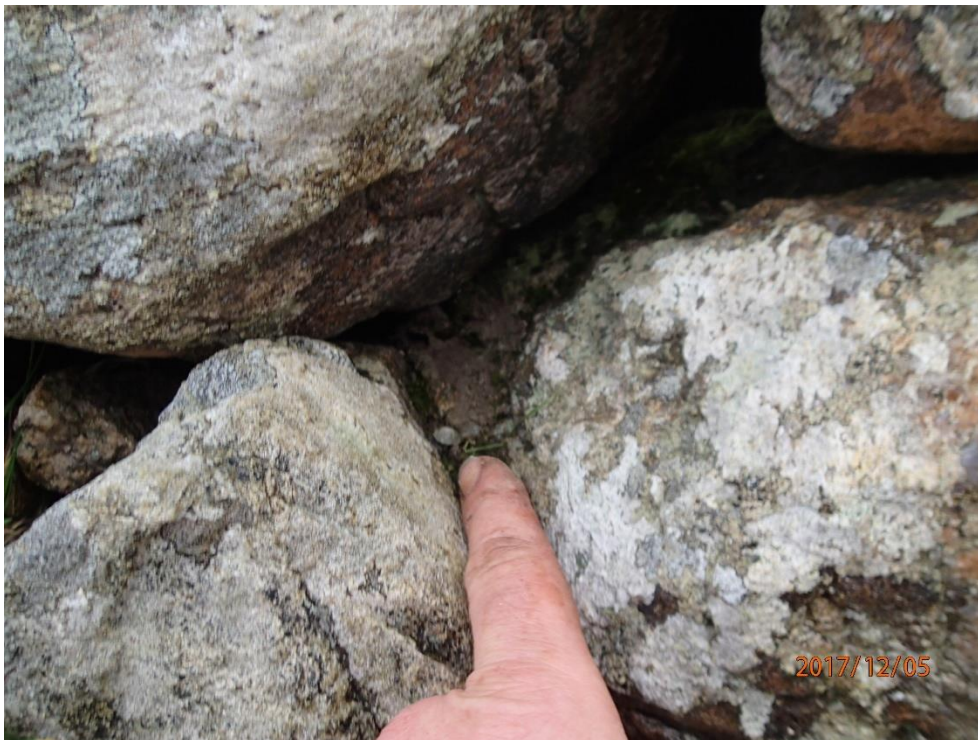
*Figure 16: Clay pointing of internal walls*

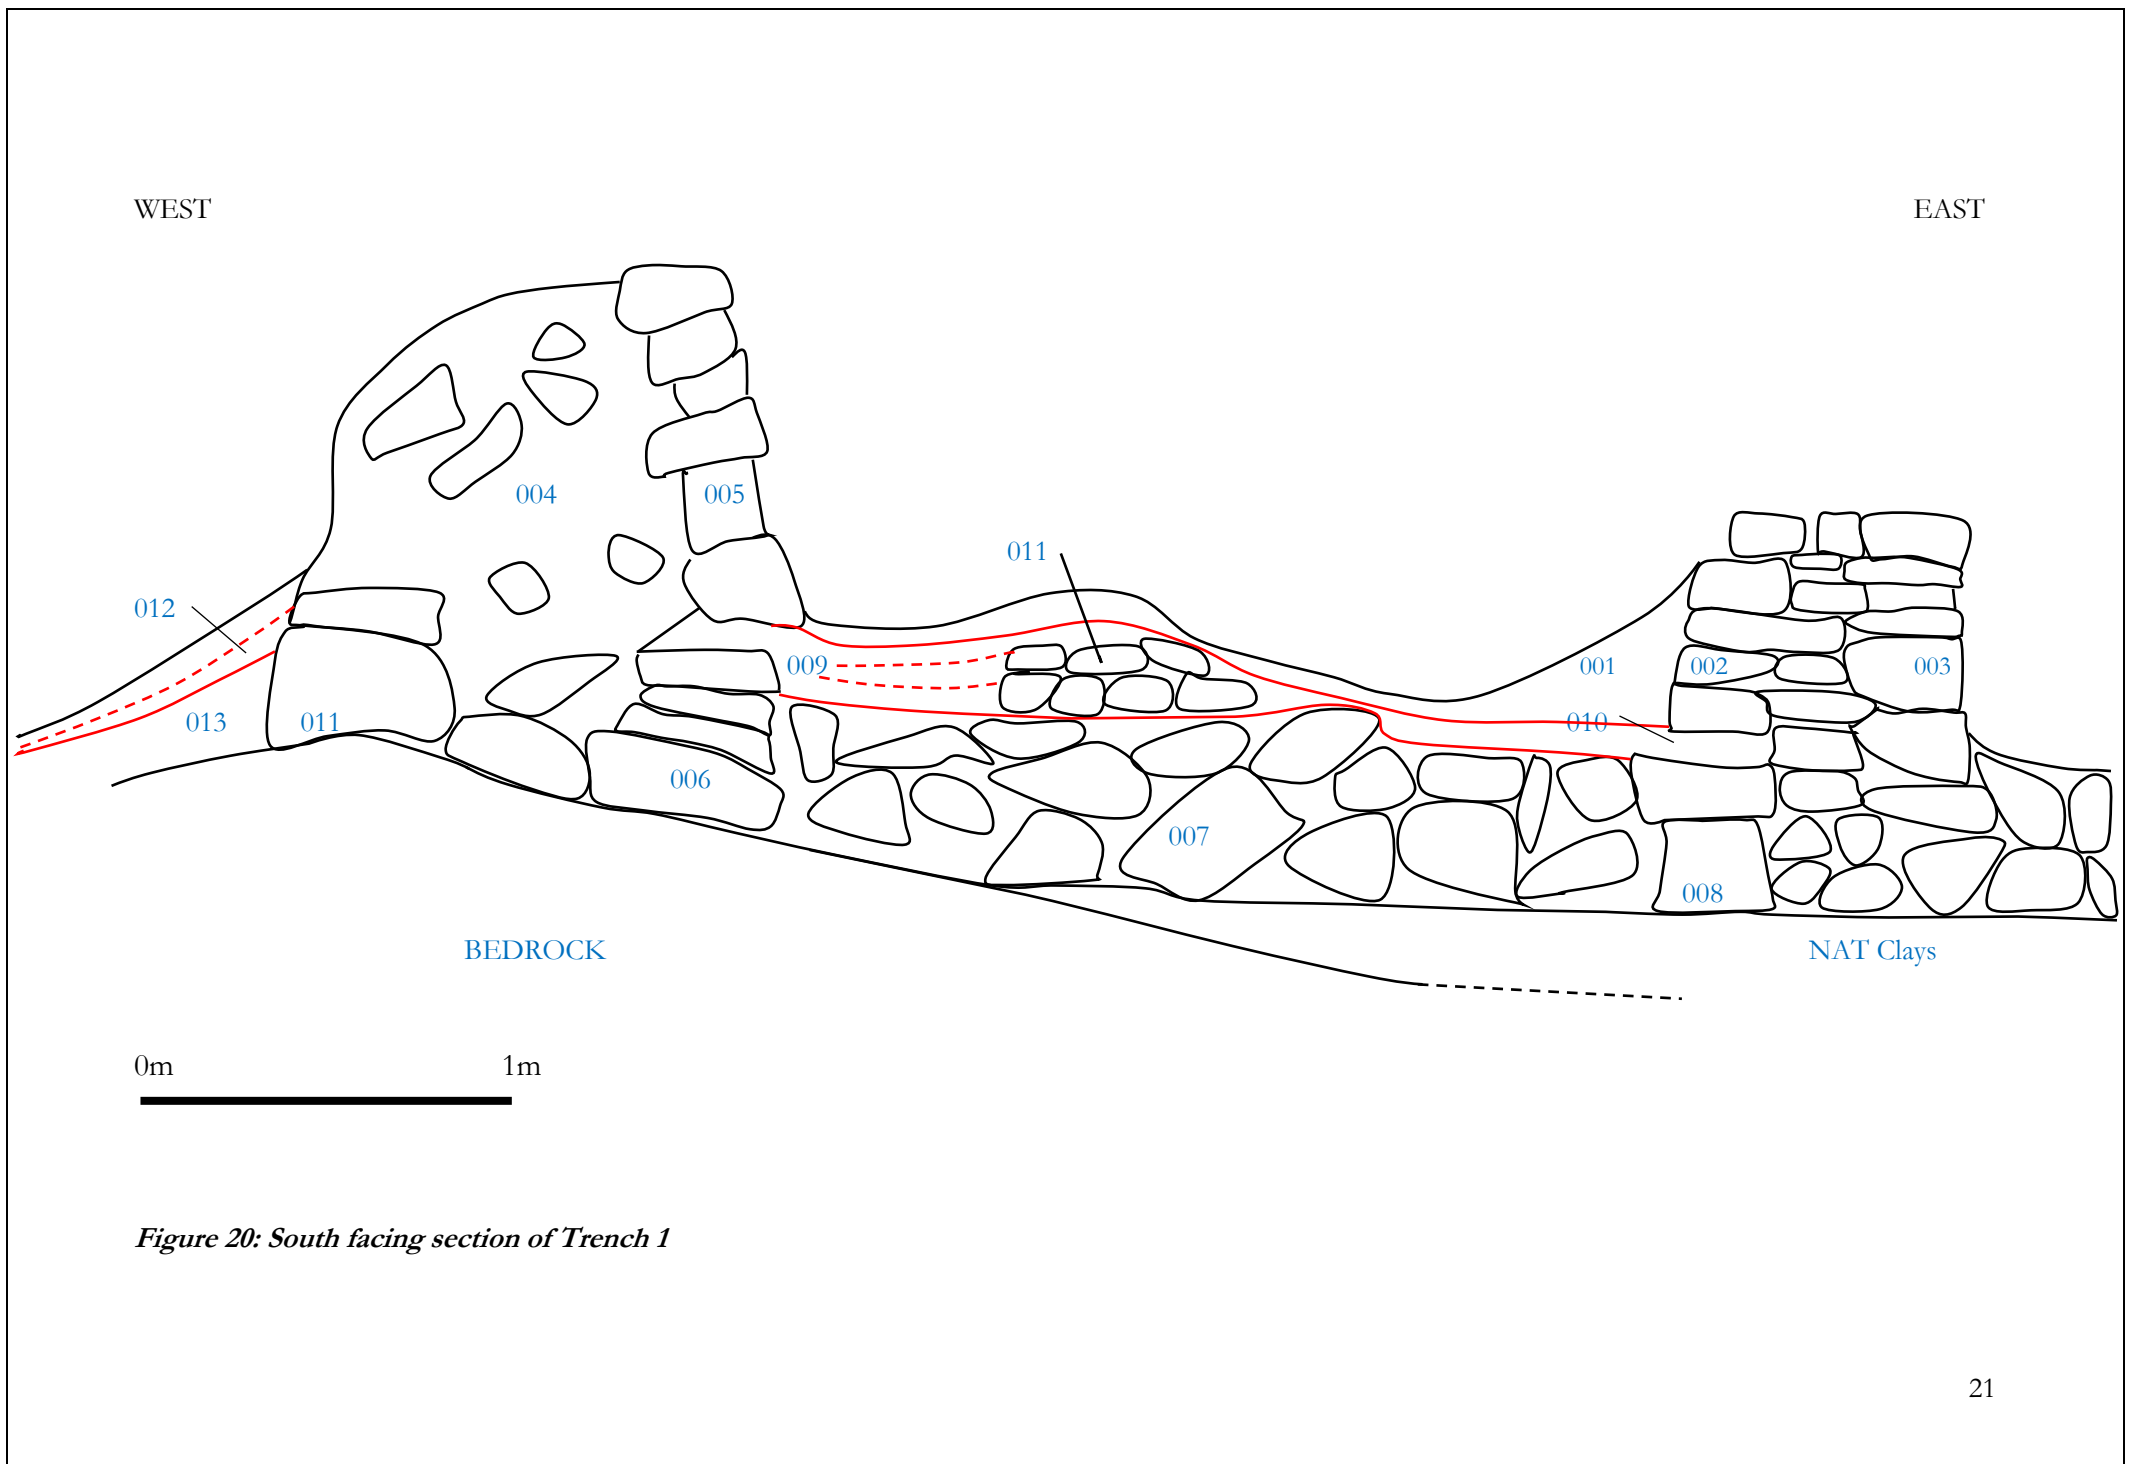
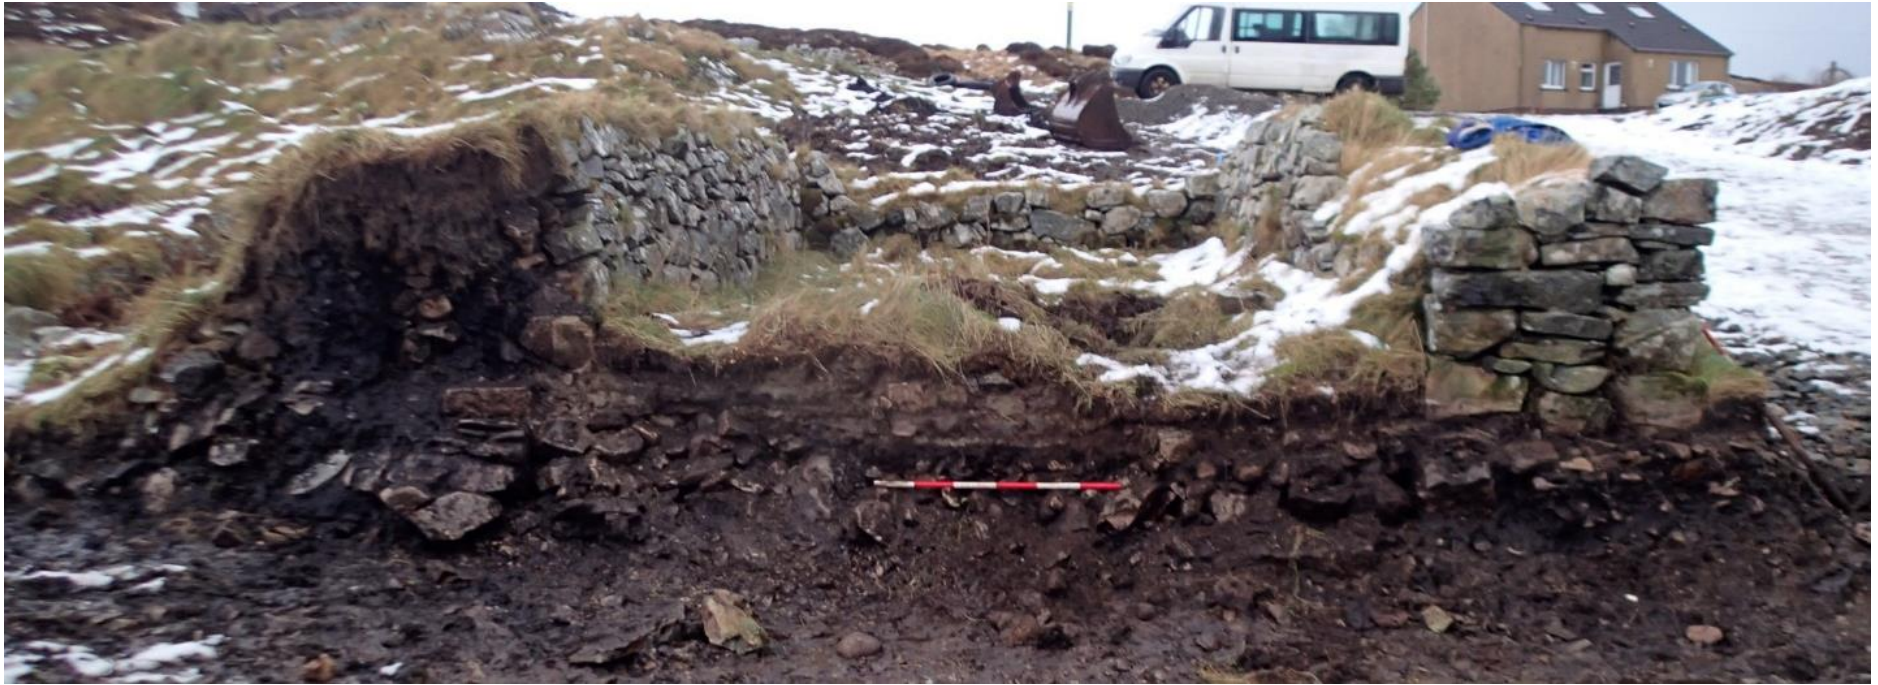
Next, occupation within the Blackhouse is clearly represented by a build-up of successive layers of clay and peat (009) and (011) to the west of the interior see Figures 20, 21 & 22. A layer of topsoil and turf (001) then formed over all.

*Figure 21: Photograph of South facing section of Trench 1*

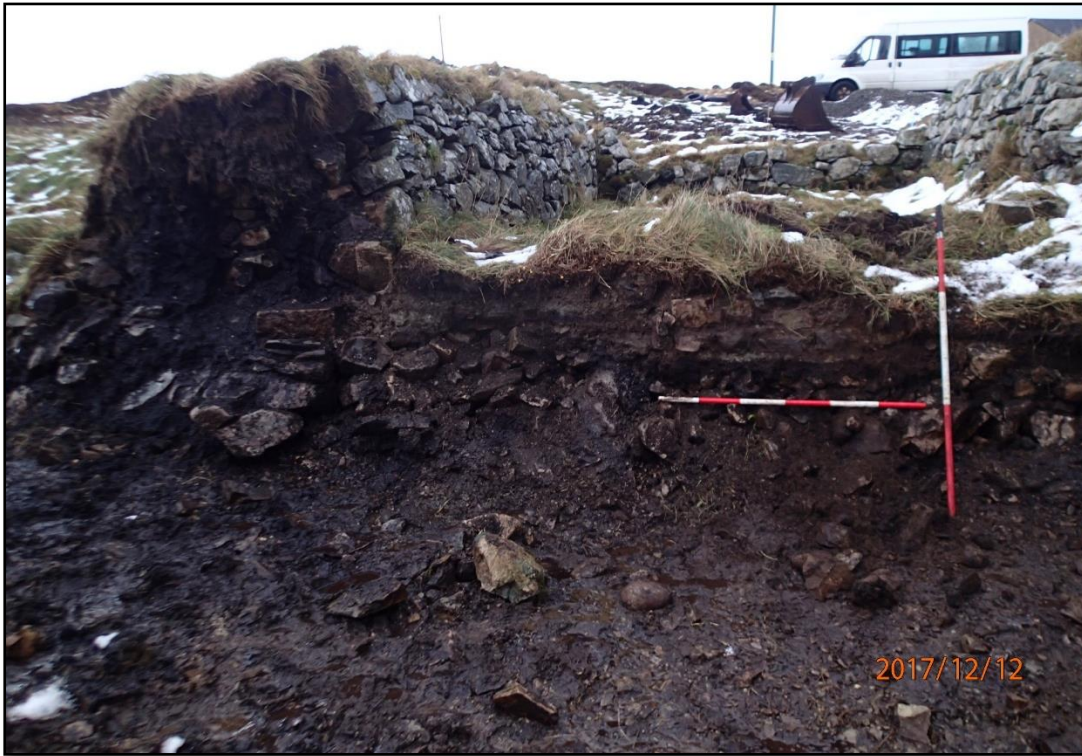
*Figure 22: West side of main Blackhouse showing Peat core (003) in wall, internal stone facing (004) and occupation layers (009)/(011)*

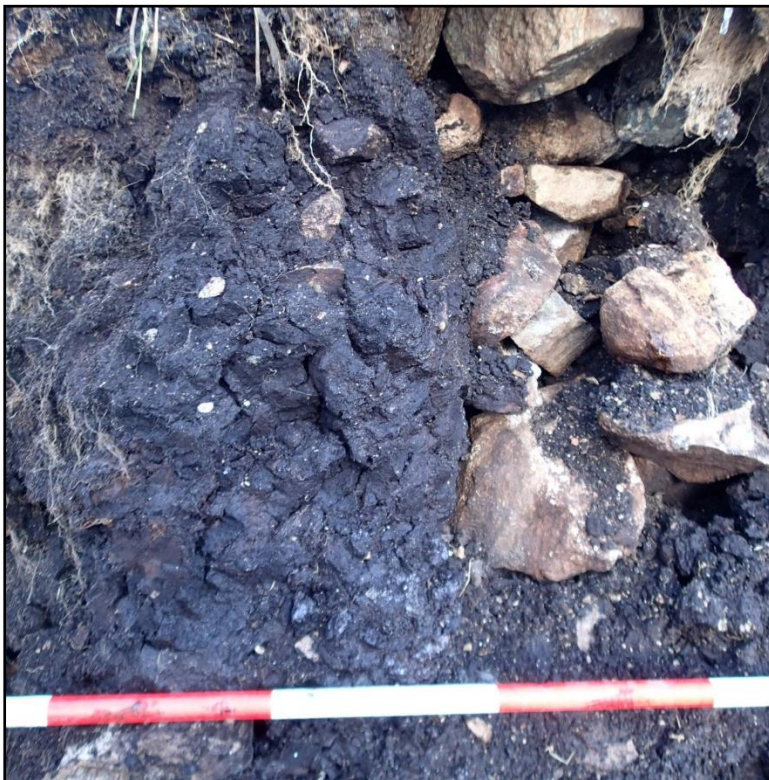
*Figure 23: Peat core of wall (003)*

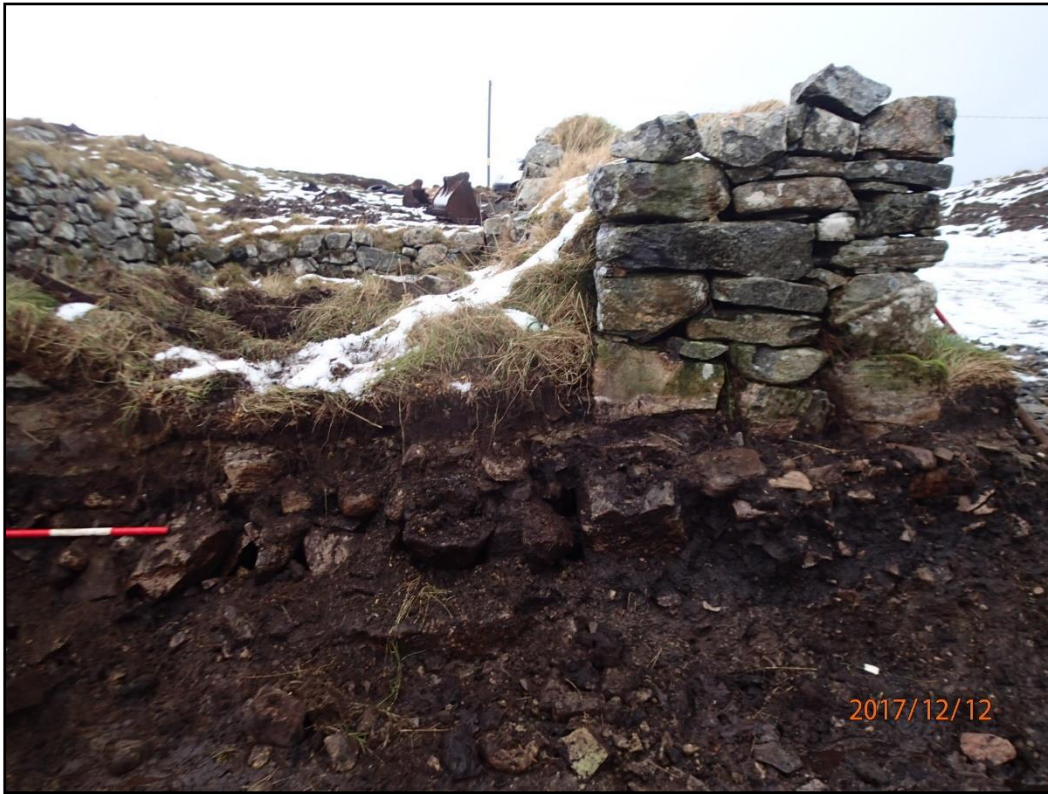
*Figure 24: East wall (002)/(003) and foundations (007)/(008).*

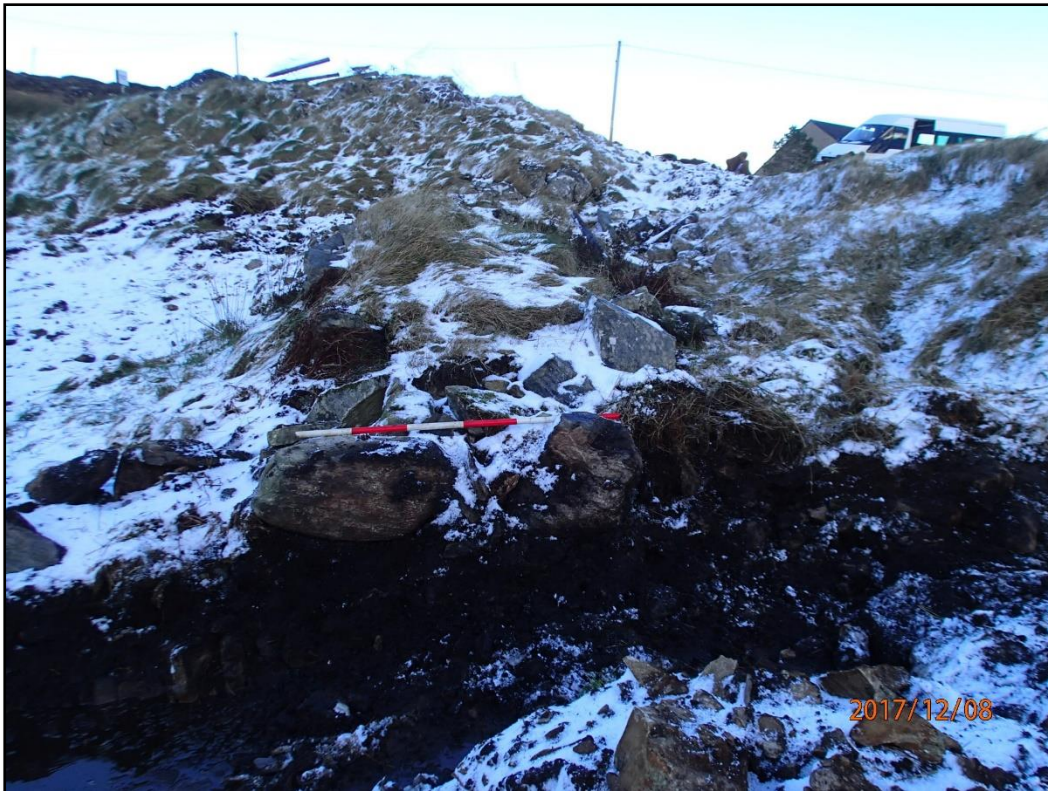
The section cannot tell us whether the Blackhouse stood on its own for any length of time, but it does tell us that the Barn was added rather like a lean-to extension after the main Blackhouse walls were finished. After the effort of building the main house they probably needed a break! The Barn walls were tacked on to the outside of the pre-existing Blackhouse west wall, were a bit thinner than the main ones and contained much less peat filling within them. They also had squared off corners, unlike the Blackhouse. The clay floor of the Barn (012) was patchy and difficult to make out but definitely did not run under the main middle wall, just up against it. This was the same where the clay met the Barn wall. The Barn wall (not shown on drawing) did not have the massive foundation course but instead sat upon a thin layer of peaty soil (013) which overlay the bedrock which rises up at this point.

*Figure 25: Barn wall sitting on (014) and Bedrock*

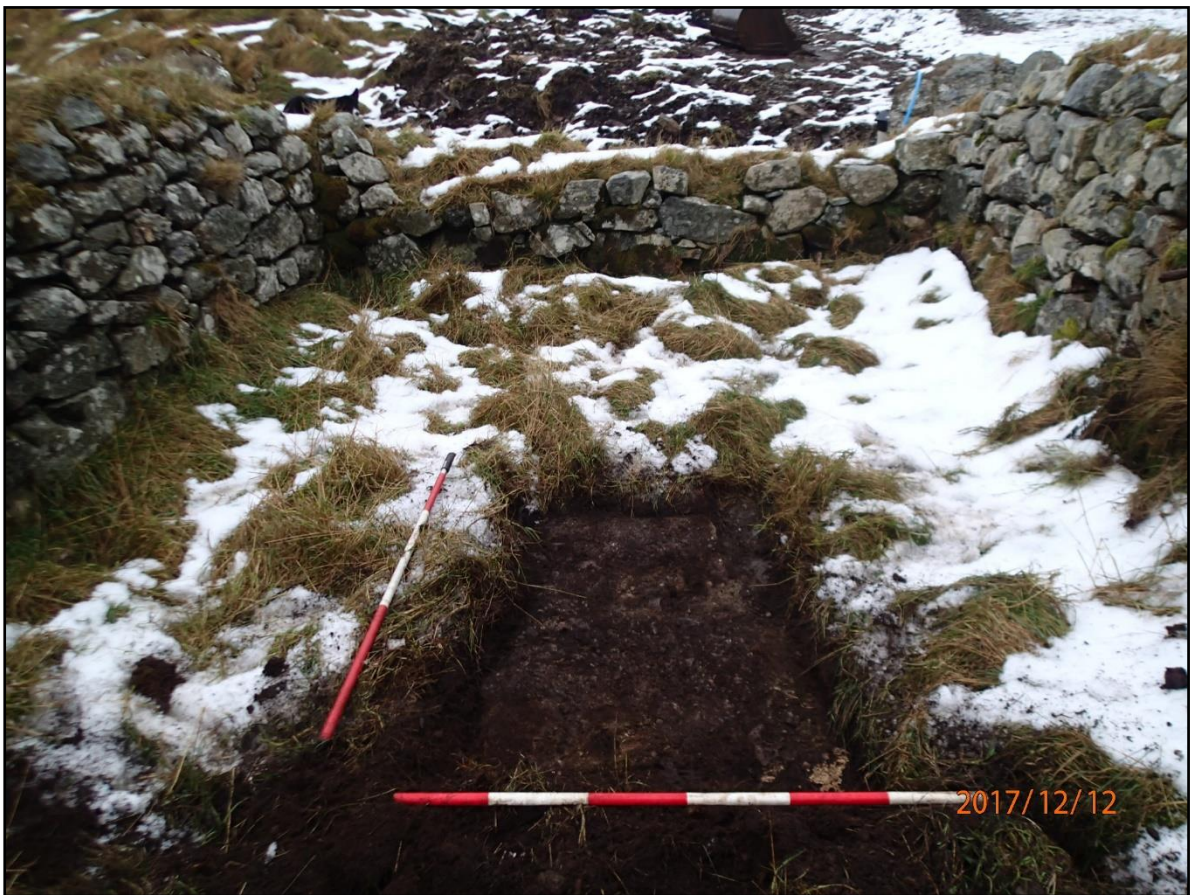
Trench 2 was situated right at the centre of the Blackhouse floor to investigate flooring material and possible hearth. The turf and topsoil were around 2-300mm thick, and peeled off like a carpet onto a concrete surface. To the east of the trench, a small patch of clay of the same nature as that seen in Trench 1 could be seen to run under the concrete. In the SE corner of T2 Lino cloth could be seen covering the concrete (see photographic record for more detail).

It seems that the clay floor was covered over by concrete and then Lino in an effort to modernise the Blackhouse. This implies that the building had a long life and was lived in until quite recently – although I do not yet know when exactly Lino (invented 1860) or indeed concrete first became widely used on the island.

*Figure 26: Trench 2 in the centre of the floor*

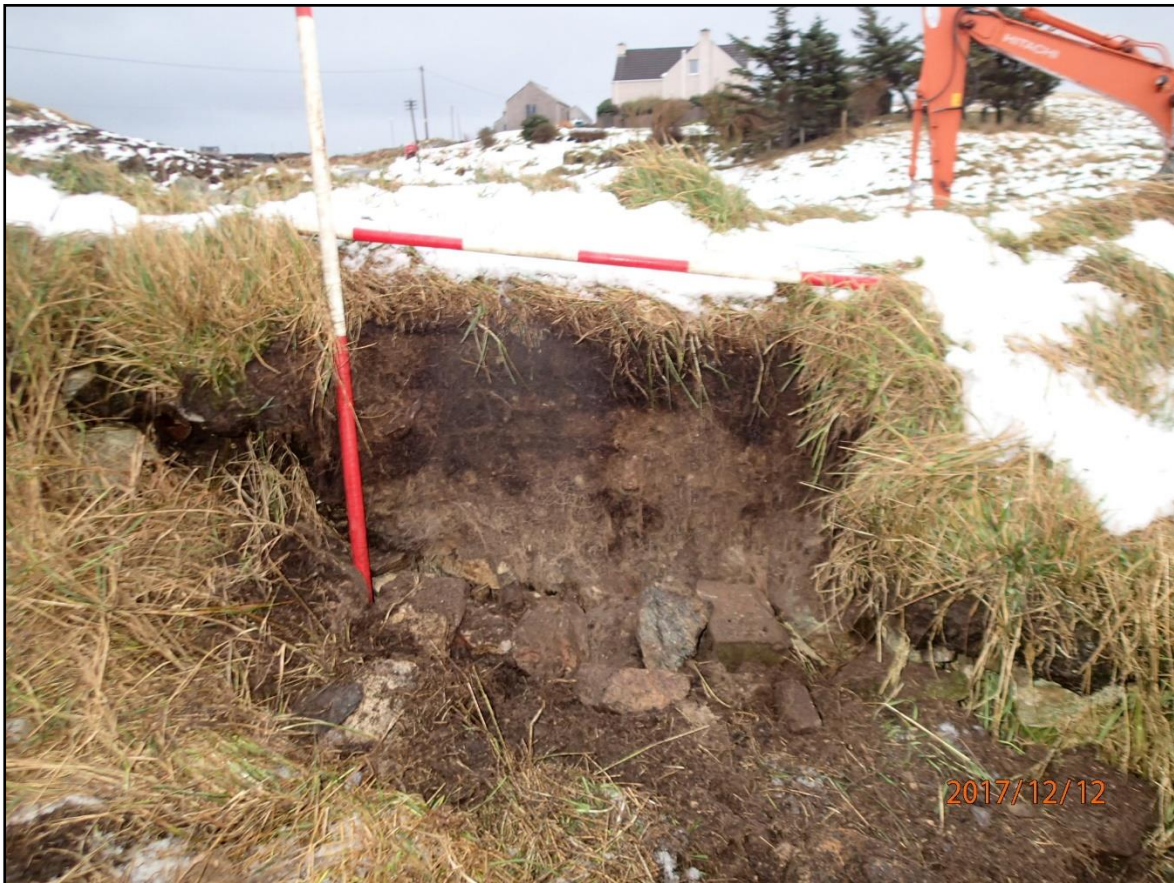
Figure 27: Trench 3

Trench 3 was situated in order to find out whether or not the walls were capped with clay as is a common feature at other Blackhouses (see McGregor and Walker 1996). The results were inconclusive. A thick layer of topsoil sat atop the wall with very few stones in it, as can be seen in Figure 27, below. Towards the bottom of this material there was indeed small lumps of similar looking clay distributed through the soil, but no proper layer such as would be required for a cap. However there was something else missing – the outside, west face of the wall (being the inside east wall of the Barn) was completely missing and the trench came down onto the internal wall fill of peat and random stone.

It would seem sensible to suggest that the stone from this face of the wall has been robbed and used somewhere else. This would also necessitate the removal of the clay cap, which would then only remain as random small lumps in the general area, as was observed.
