# A Detailed Building Survey of 74 Keith St, Stornoway; Lady Matheson's Industrial Female Industrial School or Seminary

FEBRUARY 2019

Authored by  
Ian Mchardy BSc (Hons), AIFA.

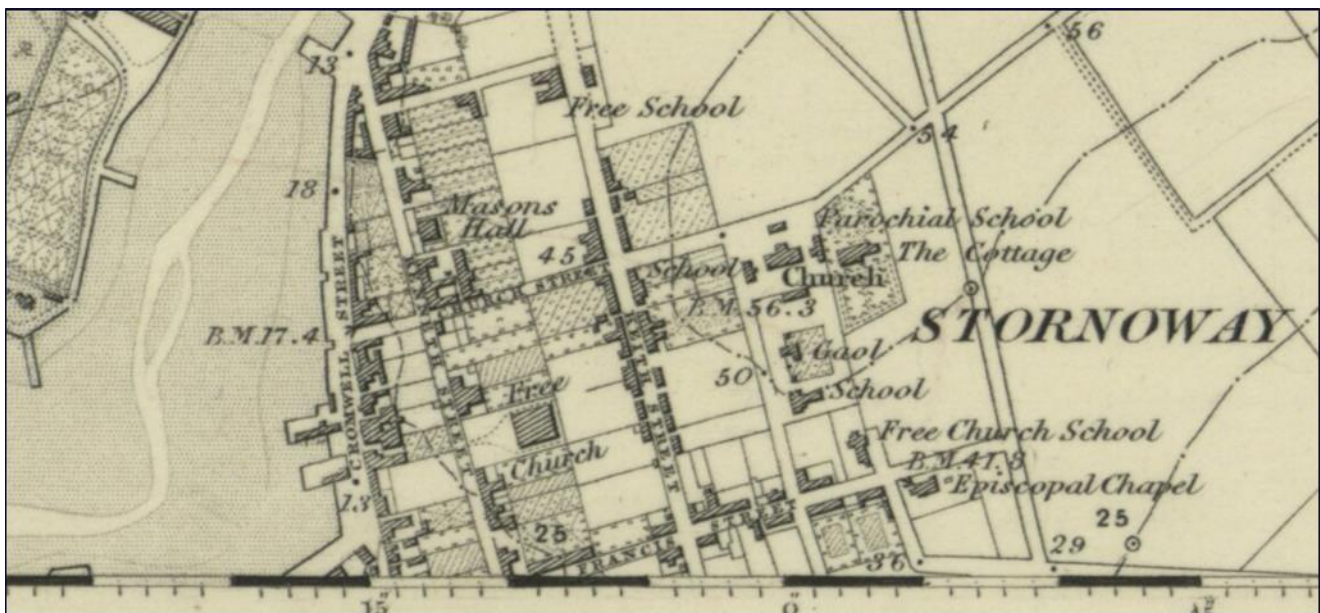
**Figure 2: OS 1<sup>st</sup> edition Stornoway. 1849. Lady Matheson's School is to the top of the figure, labelled "Free School".**

As can be seen from the 1<sup>st</sup> edition map of Stornoway (Figure 2, above, entitled "Free School" towards the top of figure) the U- shaped School looks to have been built a little

Note: The building was never L- plan – see Figure 2, 1<sup>st</sup> edition OS map, surveyed only one year after the School was built. It is difficult to imagine how this mistake could have come about. This is the only source to suggest that the two Keith St dormers were not original.

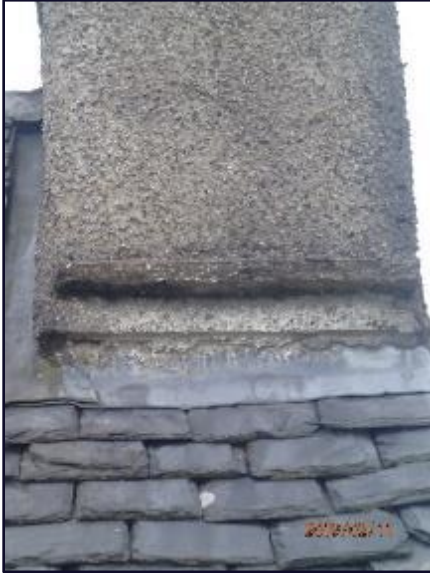
**Figure 10: Weathering Slate on NW Chimney stack**

The slate is thought to be from Easdale<sup>14</sup> in the inner Hebrides. Copper nails were used (see photo no. 171). Various authors mention repair with a different purple slate, although this is no longer visible. All of the slate from the main Keith St section of roof was removed around 15 years ago by the Stornoway Trust in order to make it safe (D. MacLennan pers.comm.). Large plywood sheets were then attached over the original Pine Sarkin boards, and covered in felt, with batons to hold the felt in place. 150mm of rubble and cement had to be added to the western Nepus gable to raise it up to the level of the plywood.

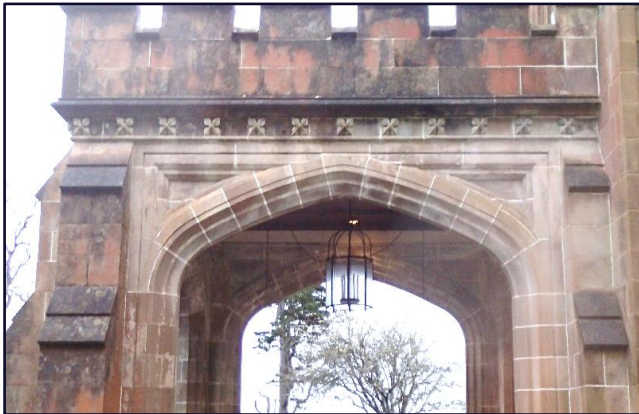
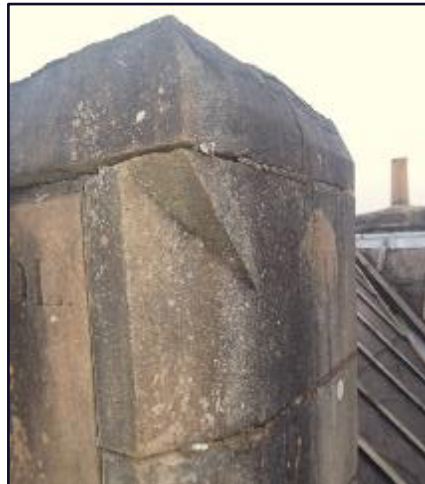
The same sandstone can be found on the skews and skew puts, with pleasingly chamfered edges, but nowhere else on the building. It must be noted that the stone and its treatment are very similar to that found at Stornoway castle, which was already under way when the School was commenced.

***Figure 11: Ornate carving in Sandstone at the Castle (left) and the School (right)***

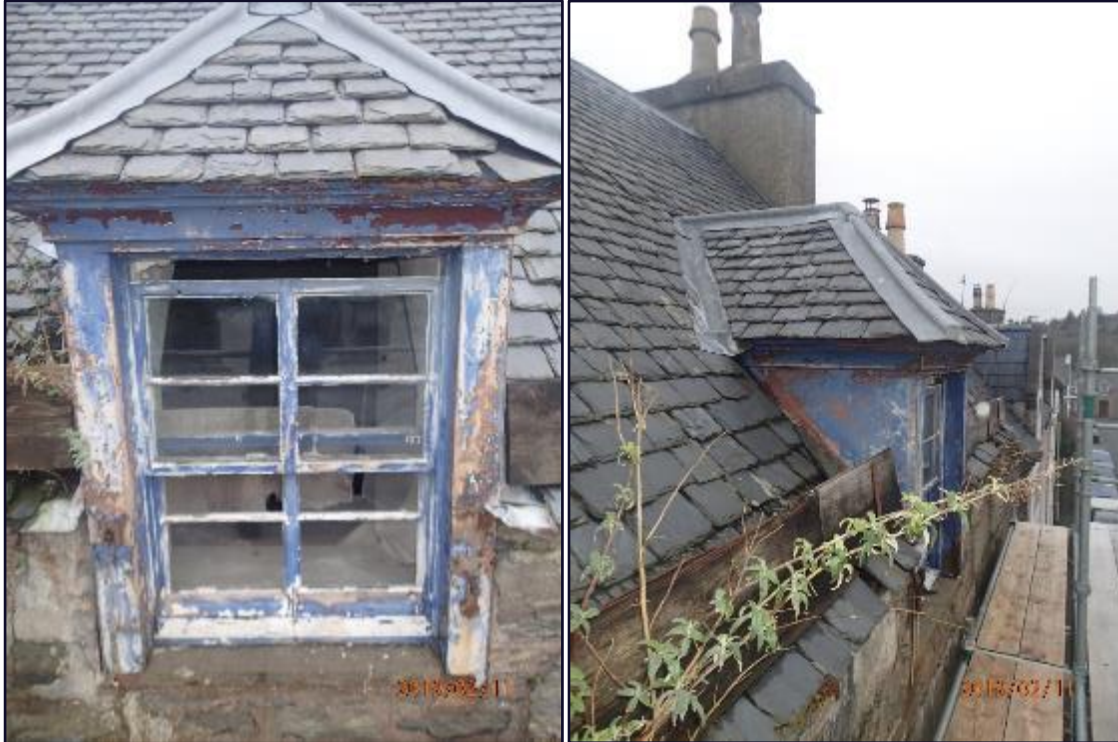
The northernmost adorn the Head Teachers accommodation and are the most well-appointed. They are set so that they break the wall head, with approximately half the window below the wall head. They are hipped or piend and have been provided with a pleasing cornice molding where they join their slate roof. They make use of thick slate slab for the cill.

**Figure 12: Dormers on Scotland St facade**

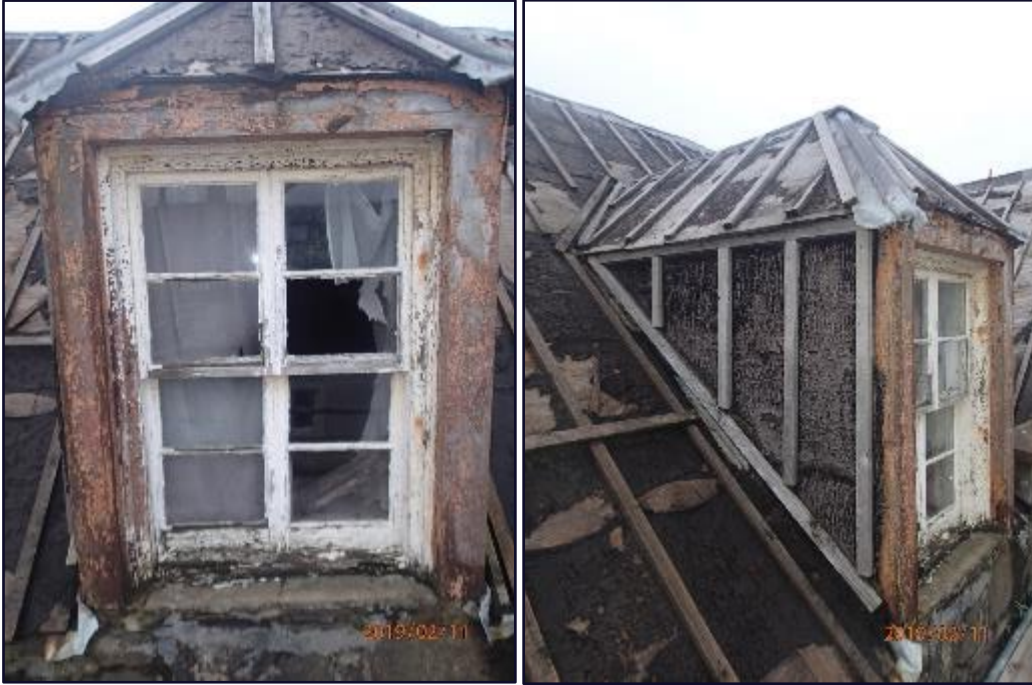
Those on the main Keith St (Eastern) elevation are set higher and do not break the wall head, possibly due to practical considerations such as headroom for the classroom below and the amount of light permitted to the classroom above. However it has also been suggested that these Dormers were a later addition to the building, and not breaking the wall head would be consistent with this<sup>15</sup>. Although still hipped/piend, they are of a simpler form than those to the north, with no cornice. They also use slate for the cills.

**Figure 13: Dormers on Keith St facade**

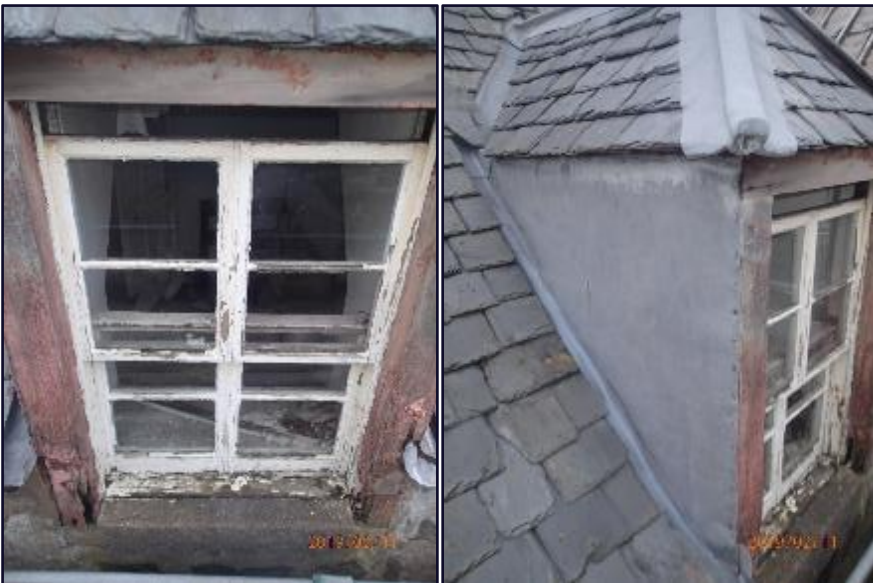
Finally, the dormers on the southern side of the building are set with just a quarter of the window below the wall head, are hipped/piend but again with no cornice. Here the Cills are made from Concrete, which is unusual. Perhaps these dormers have been substantially repaired at some time.

**Figure 14: Dormers on South facing facade**

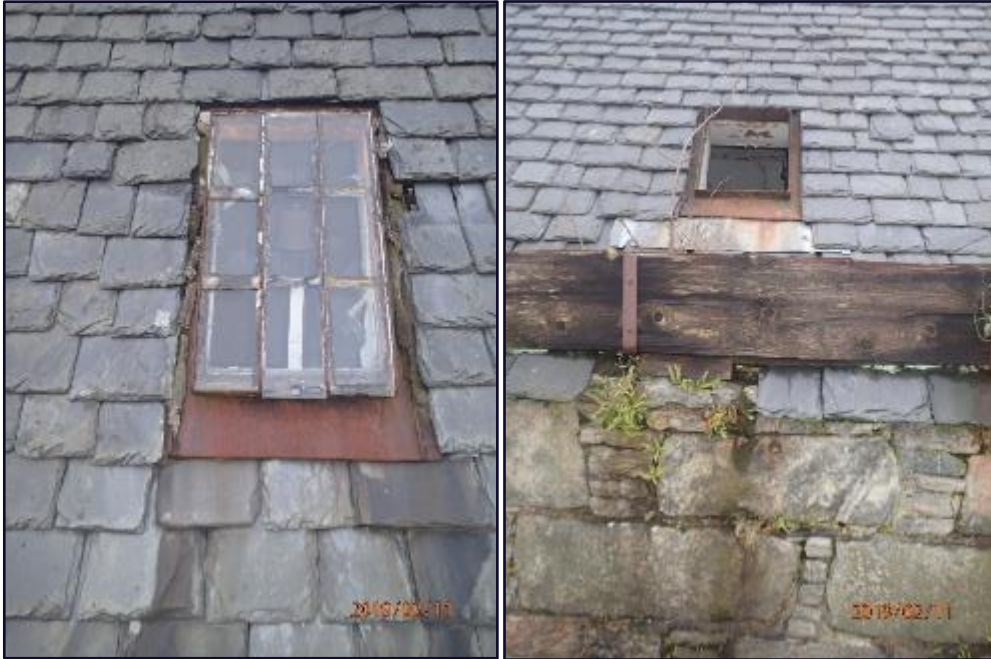
**Figure 15: The two different types of Roof light**

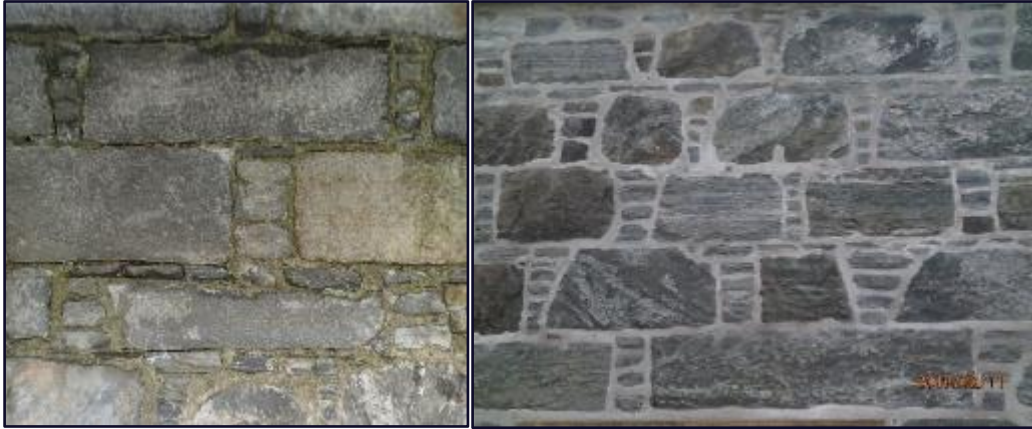
**Figure 16: Decorative pinning stones, School wall to the left, Castle wall to the right**

Again, this is echoed at the Castle, implying that it was the same group of Masons, or at least that the Masonry styles were deliberately kept similar over the two buildings.

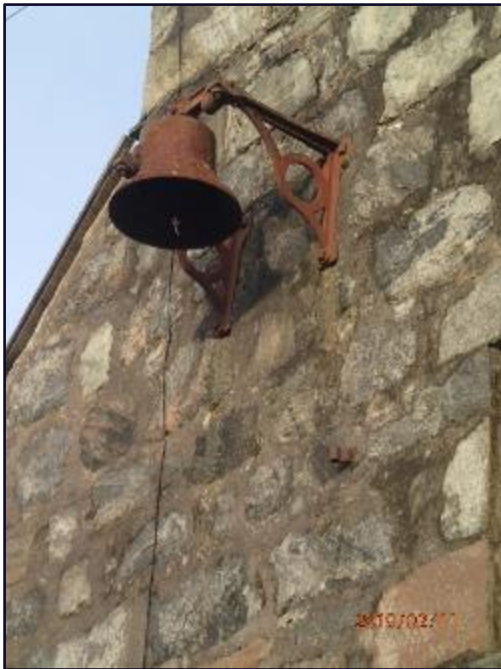
On the south side of the building, nearest the playground, the original School Bell remains. A small iron fitting in the wall below it may be a guide for the bell rope or chain.

**Figure 18: The School bell and rope guide**

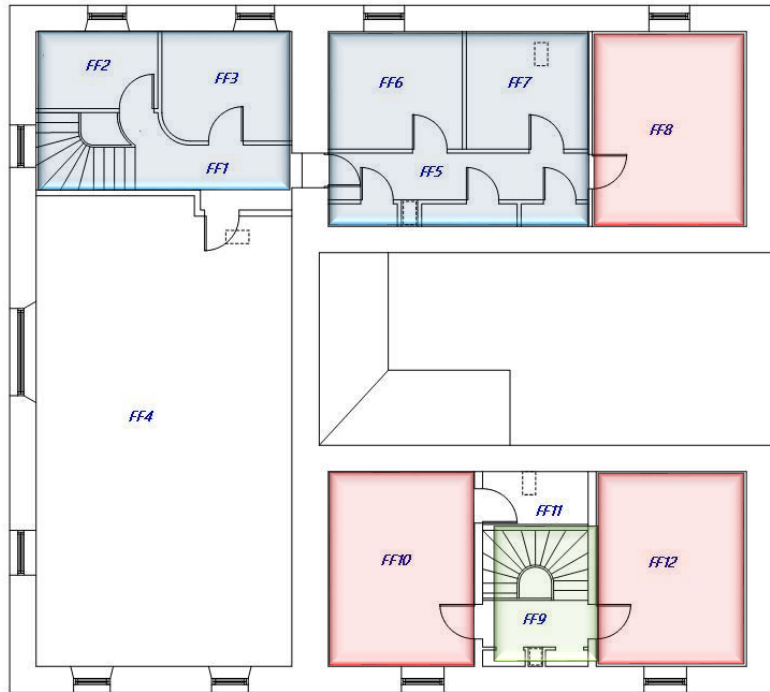
**Figure 23: First Floor Skirting Boards**

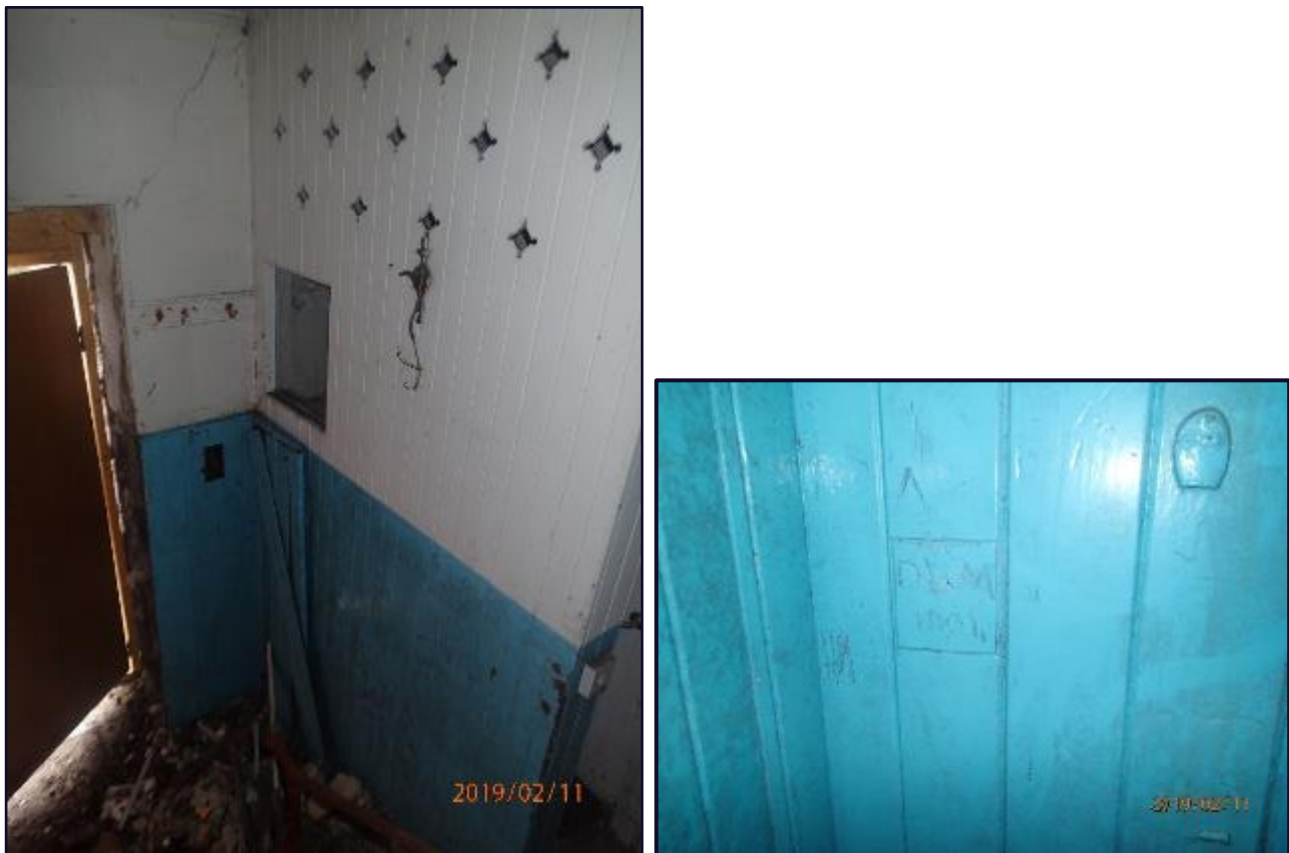
A toilet, GF2, has been added to GF1 at some point and is not part of the original build. This can clearly be seen by observing that the coat rail and dado paneling run behind the wooden partition walls which create the toilet.

**Figure 23: GF1 and GF2, showing decorative ventilation and graffiti**

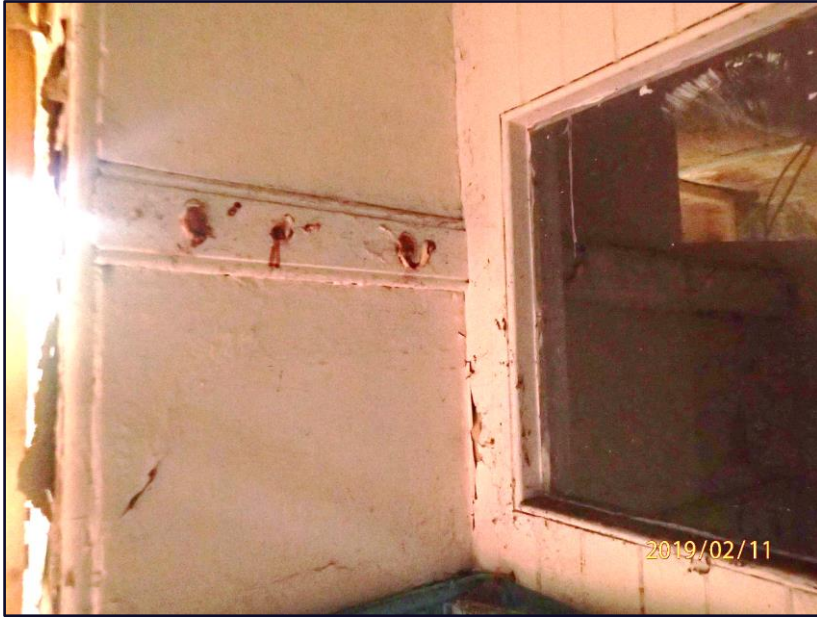
**Figure 23: Coat rail running behind Toilet wall, an into toilet, as seen through glass**

However the toilet incorporates a decorative pattern of ventilation holes in its design which has nonetheless been considered “an attractive feature worthy of retention”<sup>21</sup>

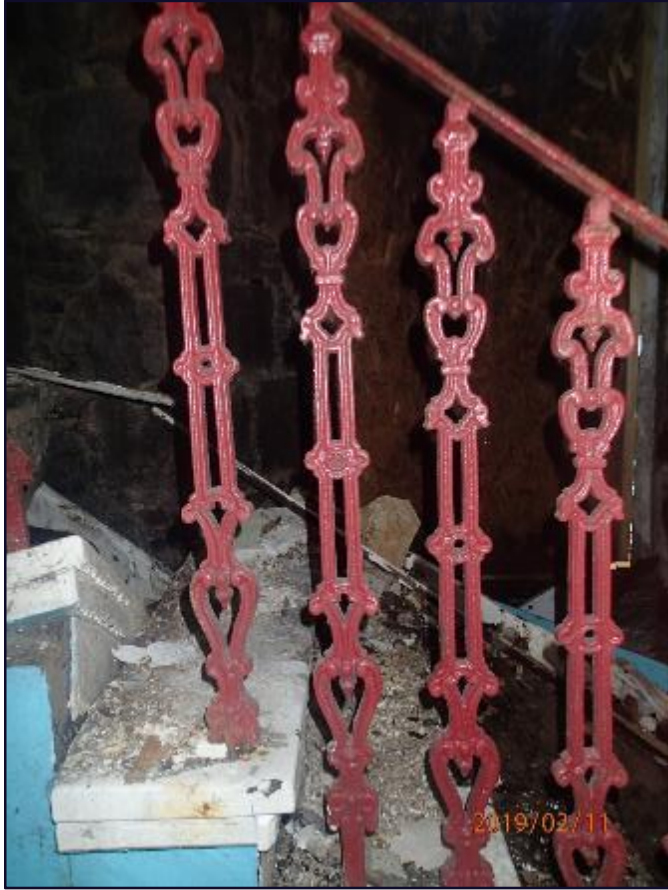
**Figure 24: Decorative cast iron Banister supports**

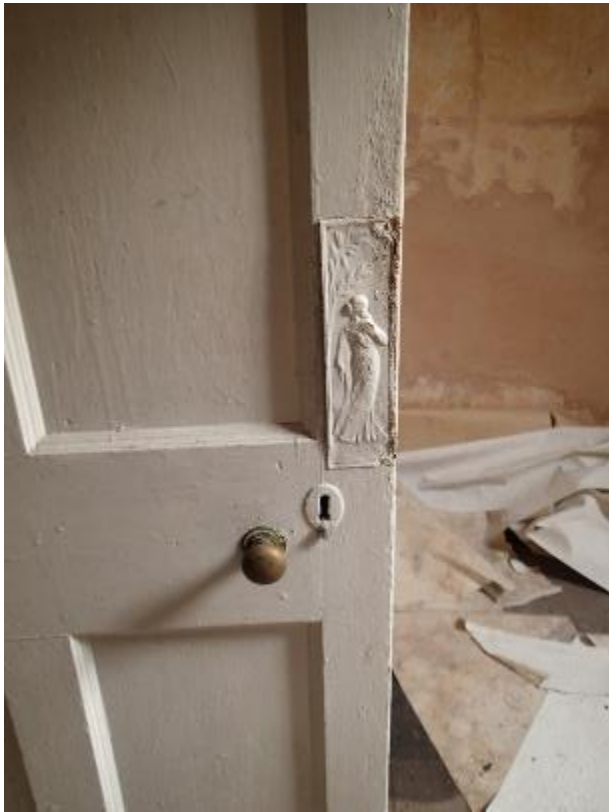
***Figure 25: Decorative fingerplates on door to FF6***

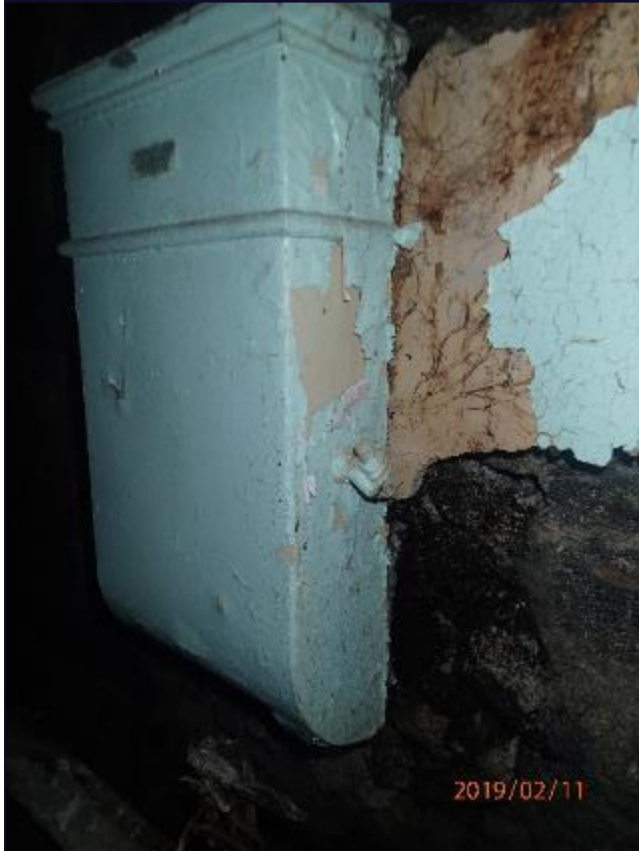
***Figure 26: Wall Ventilator designed and made by Robert Boyle and sons, Glasgow***

Thanks to a website called “The Internet Archive”, a non-profit, free to access digital library, we can access Robert Boyle’s original sales brochure and find the exact models of “Air inlet Brackets” and even “Air inlet Grilles” which we find at 74 Keith St.:

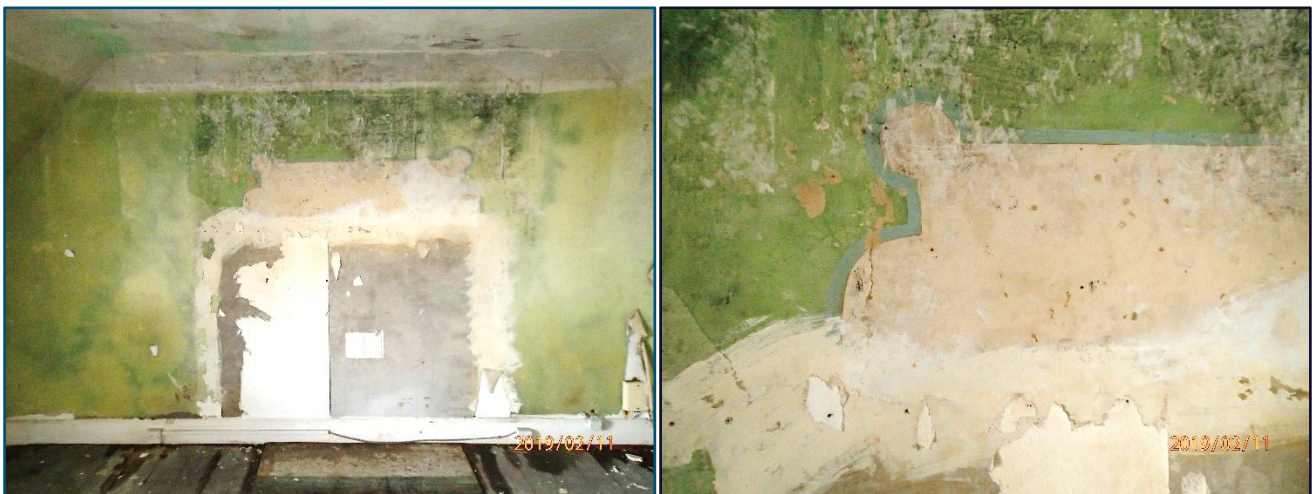
To the east, FF10 is almost identical, also with Type 'D' skirting and Type '2' door frames, but this room also has another doorway to a small ante room FF11, described below. Interestingly, the continuing disintegration of the building has led to the discovery of an original wall covering in this room which has never been recorded before - on the three load bearing walls, the modern wall paper has fallen off since the previous study to reveal a 'Distemper' colouring, a paint applied directly to the plaster. This has been artfully applied around the (now blocked up) Hearth in the eastern wall, as if to surround the mantel piece and whatever it supported, perhaps a mirror? See figure 29, below.

**Figure 29: FF10 and decorative distemper painting around now blocked up hearth**
