# A Basic Building Survey and Archaeological Evaluation of a Blackhouse at No 28 Lemreway Isle of Lewis

**AUGUST 2019**

Authored by  
Ian Mchardy BSc (Hons), AIFA.

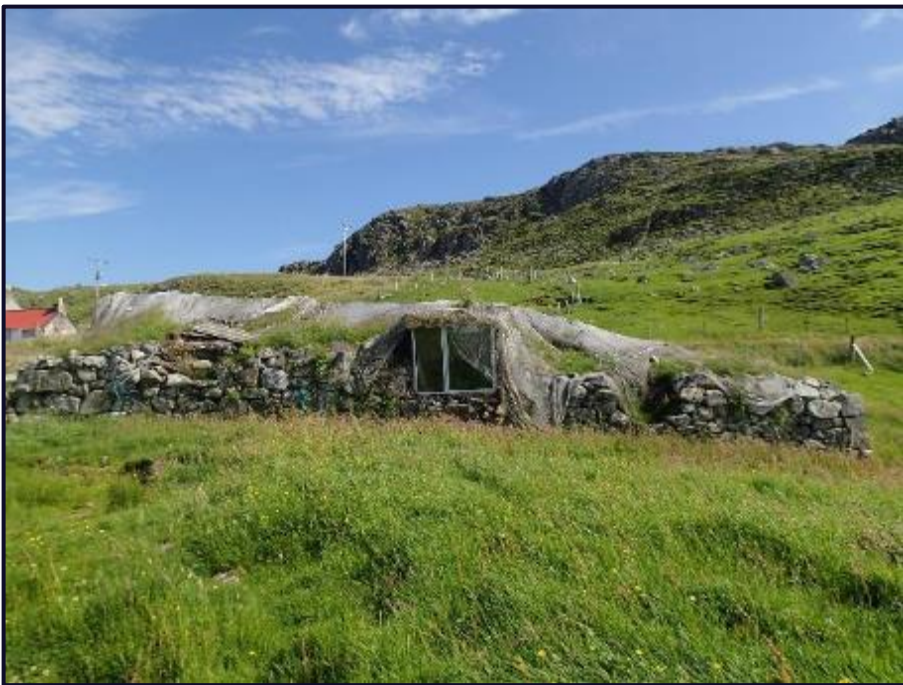
*Figure 13: South wall with windows*

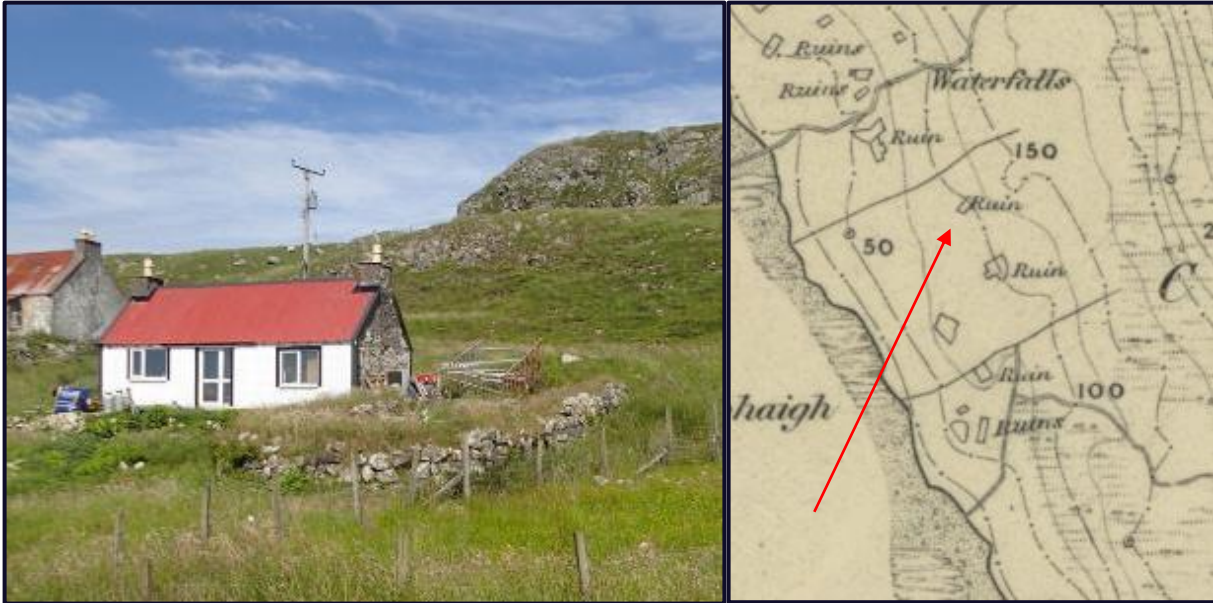
Then, if we look at the only blackhouse which does remain from the 1st edition – figure 8, below – we see that it has rounded corners, like most old blackhouses. If we look at all the blackhouses which were built by the time of the 2<sup>nd</sup> edition, they all have the square corners, gables with chimneys and built in window sockets – see figure 9, also below. So we seem to have two phases of blackhouse design, one from before the clearance of Lemreway and one from its re-settlement, neatly captured between the two OS editions, illustrated by the two blackhouses built at No. 28 and still visible in the surrounding landscape.

**Figure 26: Neighboring Blackhouse (just to the right of the whitehouse), present on OS 1st edition, exhibiting rounded corners.**

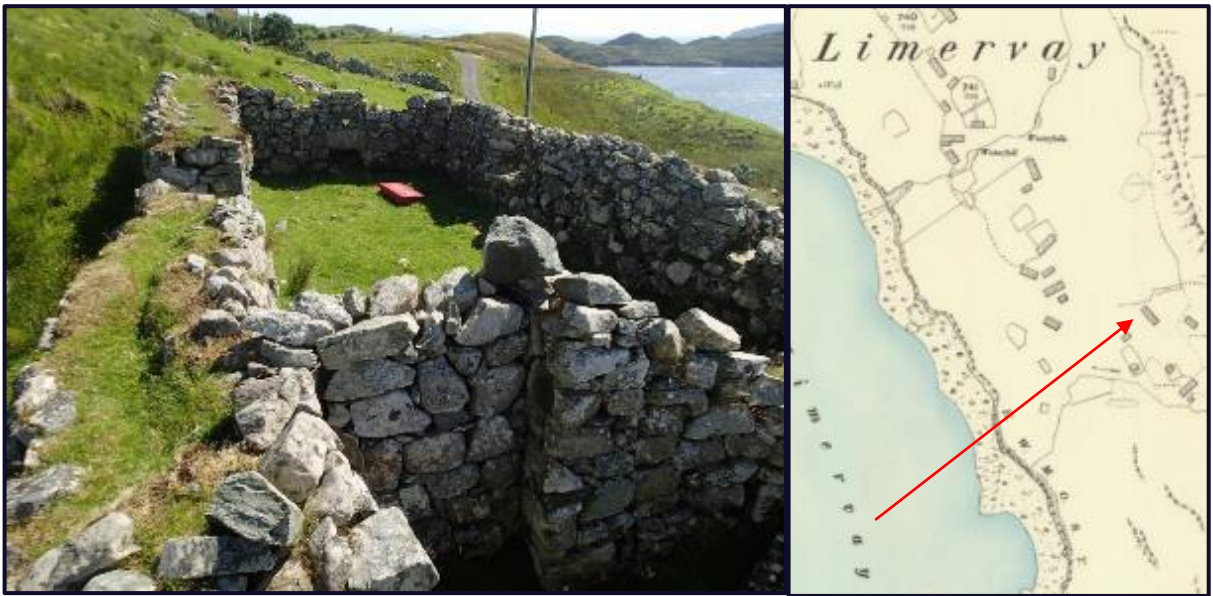
**Figure 27: Neighboring Blackhouse from 2nd edition exhibiting square corners, a gable with a chimney and built in windows.**

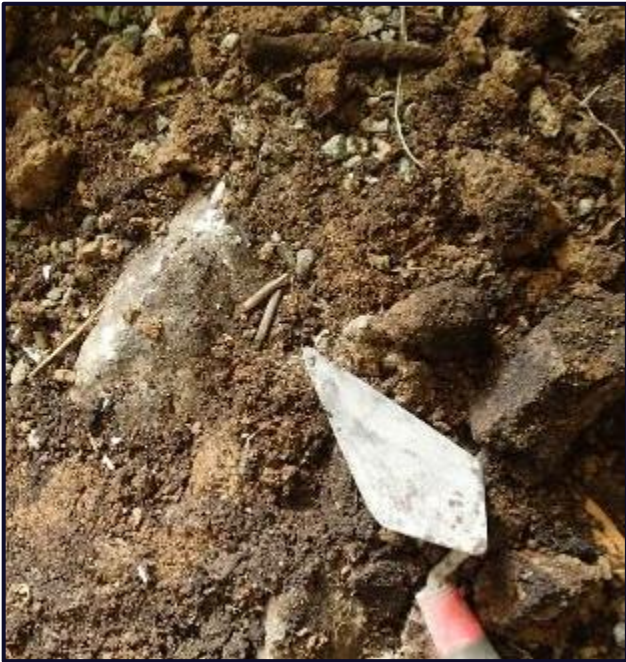
**Figure 29: Graphite pencil found in wall fill**
