A Basic Building Survey and Archaeological Evaluation of  
a Black house at 9A Grimshader,  
Isle of Lewis.

By Ian McHardy, B(Sc) Hons,  
Associate of the Chartered Institute of Field Archaeologists (ACiFA)

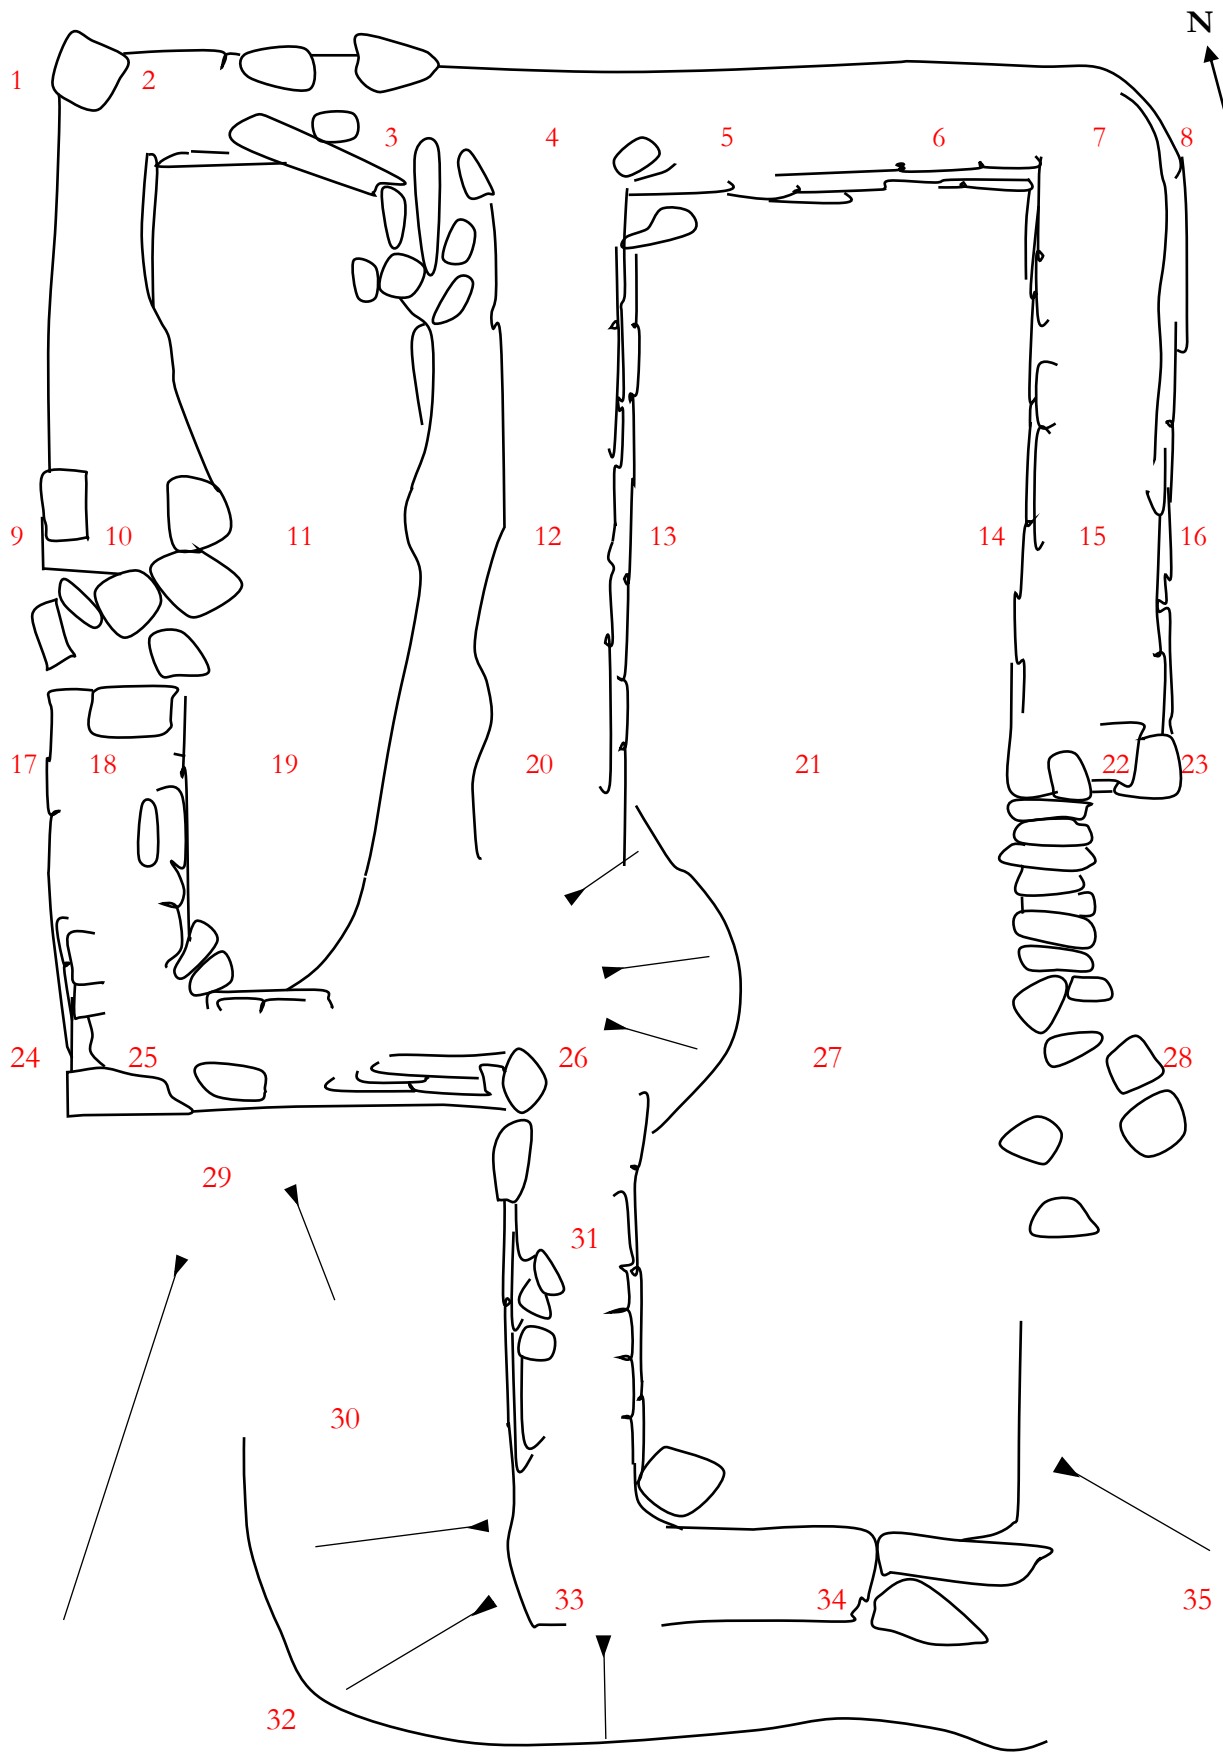
0m 4m  
**Figure 18: Position of Levels at 9A Grimshader, see table below for values**

The TBM was taken at the side of the tarmac road, roughly in the centre of where the future drive will be. This road slopes downwards to the east and no permanent mark could be made upon it so consequently we cannot return and relate these figures to an absolute Bench Mark. They do however show the relative heights and record what remains of the Blackhouse in that dimension. The position of each level is marked upon Figure 18 above in a red number.

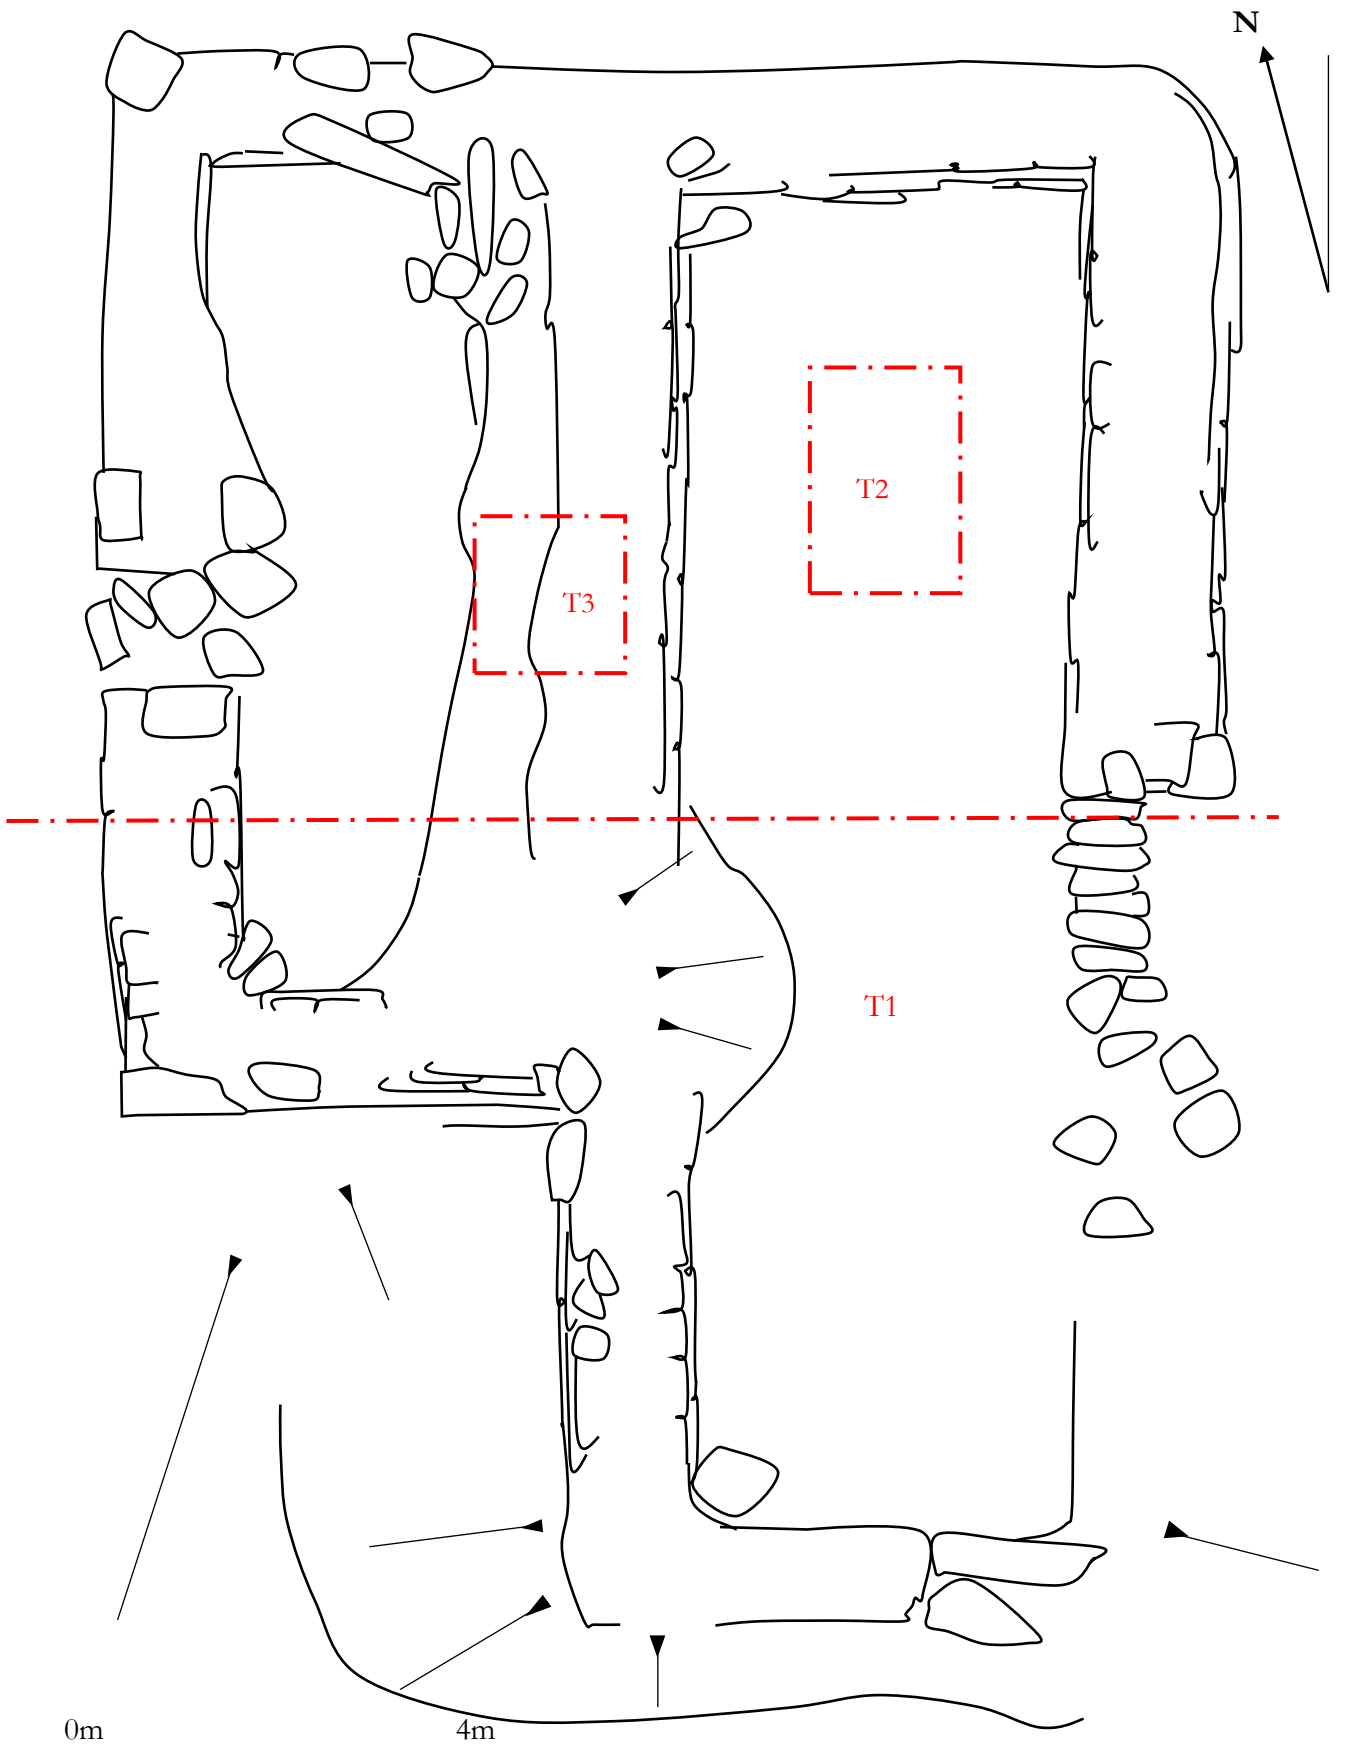
**Figure 19: Location of trenches**

In addition to this, a small 1x2m trench was excavated in the centre of the floor of the Blackhouse (T2) to investigate the flooring, and another 1x1m cut into the highest remaining section of wall (T3) to look for the wall capping.
