# An Archaeological Evaluation at 51 Knock, Aignish Isle of Lewis

By Ian McHardy, B(Sc) Hons,  
Associate of the Chartered Institute of Field Archaeologists (ACIFA)

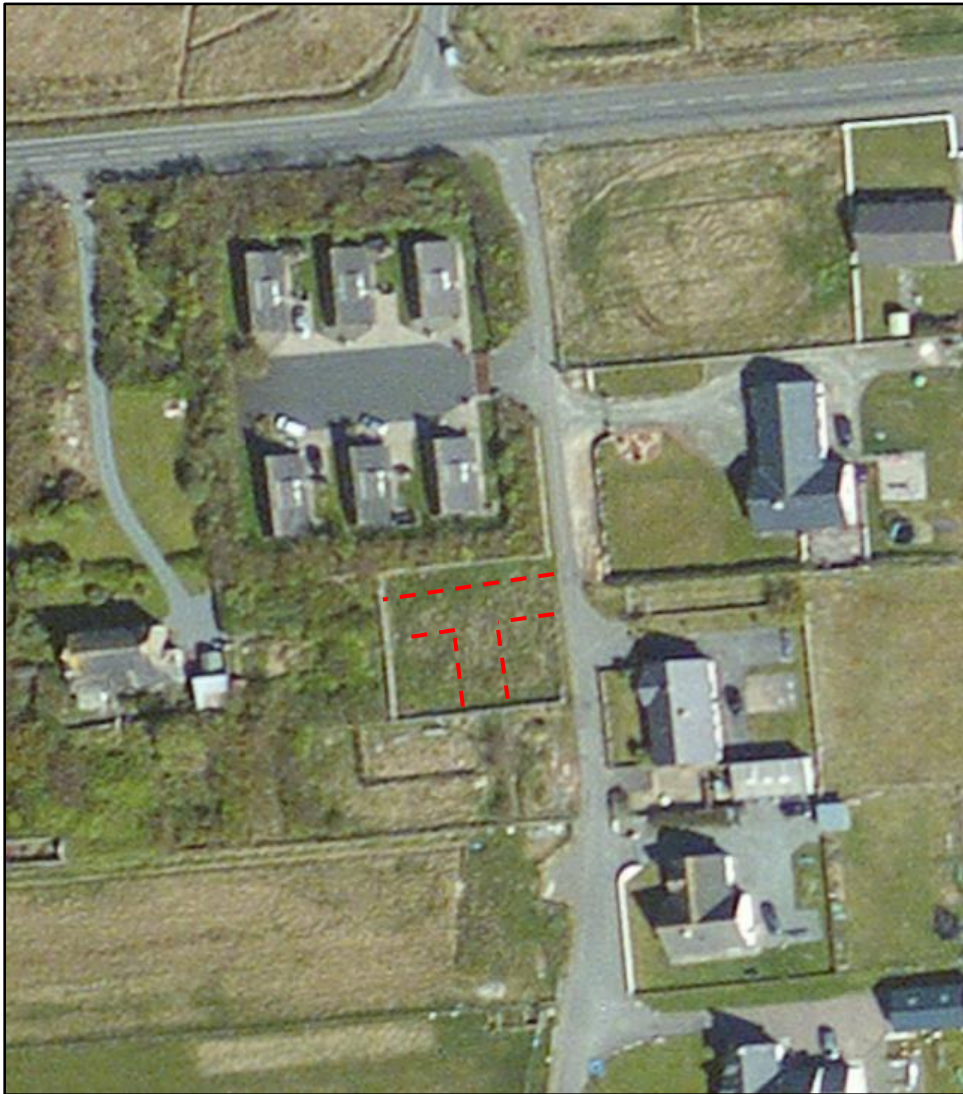
*Figure 5: Satellite image showing the site at 51 Knock and the trench location in red*

A T- shaped trench was laid out, with the E-W axis (right to left in the picture below) running along the side where both Church entrances were located. I had wanted this to be closer to the wall but unfortunately BT had laid a service cable somewhere down that side so we had to leave a strip along the wall. The N-S axis was designed to cover both the centre of the building and any deposits located outside to the South. The trench was larger than 10% but only targeted areas within this were excavated down to Natural subsoil.

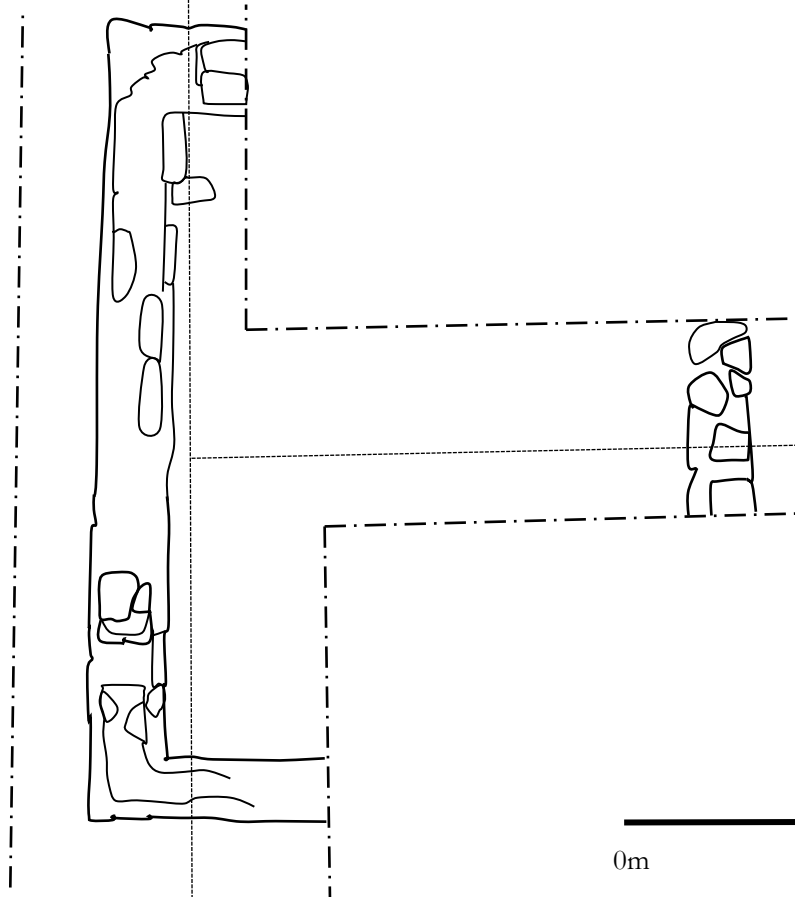
*Figure 6: Plan of trench*

ROAD

Drystane Wall  
(4.7m from Church  
wall)

6.10m from Church wall to road

Ministers gate; now blocked. 4.6m from Church wall to West dyke

The solid foundations of substantial walls were uncovered in both areas of trench, thought to be the last remains of the Telford Church

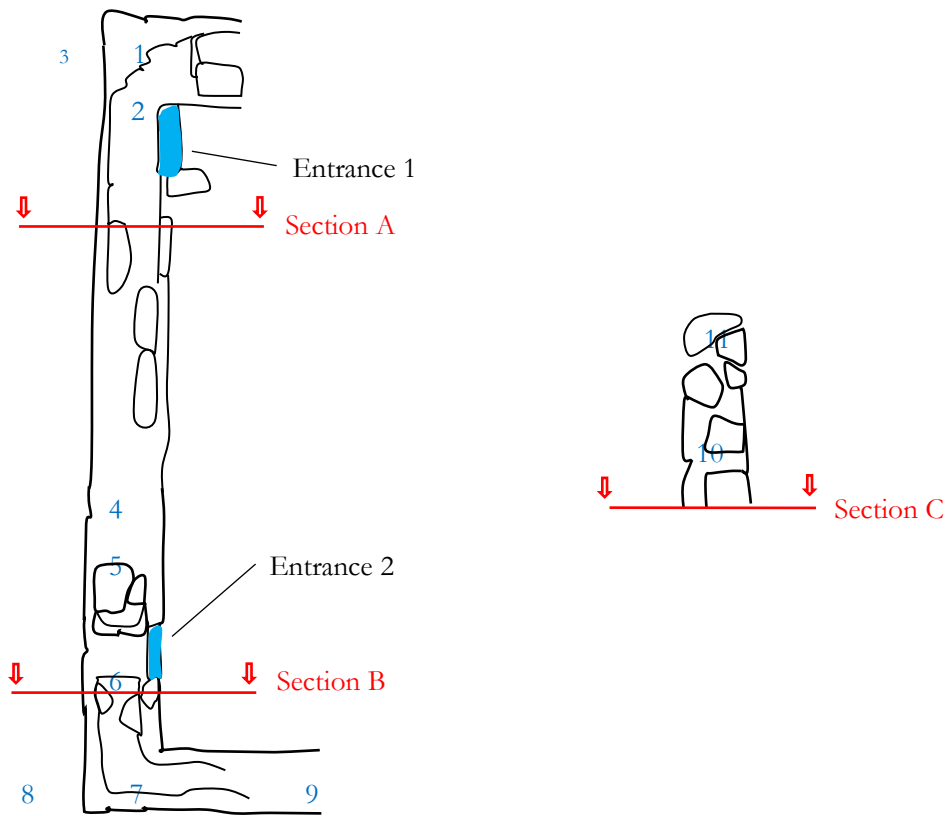
*Figure 7: Plan showing placement of cross sections in red, concrete thresholds in light blue and levels in dark blue*

Two cross sections were made perpendicular to the wall, one at each entrance way – shown in red on the plan. Slots were cut through the soils each side of the wall in order to investigate the sequence of deposition. The wall was not removed to gain a full cross section as it was too strong and substantial to do by hand.

The position of Section A can be seen on the Figure 7 above. It was situated over an area where a lower course of stone was visible under the main course that ran the length of the trench. The following reconstructed sequence was observed:

In the southern trench extension there were the remains of another, similar wall (016) – see Figure 7 above. This had been damaged by the machine somewhat and a couple of large boulders dislodged from their original position. It was constructed of the same materials as the North wall, consisting of large 300mm tall stones in a foundation course supporting slightly smaller stones which were probably the base of the upper wall (017) – which was again 700mm wide. Another section was cut across to demonstrate the stratigraphy – see Figure 11, below.

Levels were taken on the one day I had a volunteer to help out. The TBM was taken at the side of the tarmac road, roughly in the centre of where the future drive will be. The position of each level is marked upon Figure 7 in a dark blue number. I did not manage to ascertain an absolute level for the TBM, therefore all levels are reduced to show their height relative to the TBM only.

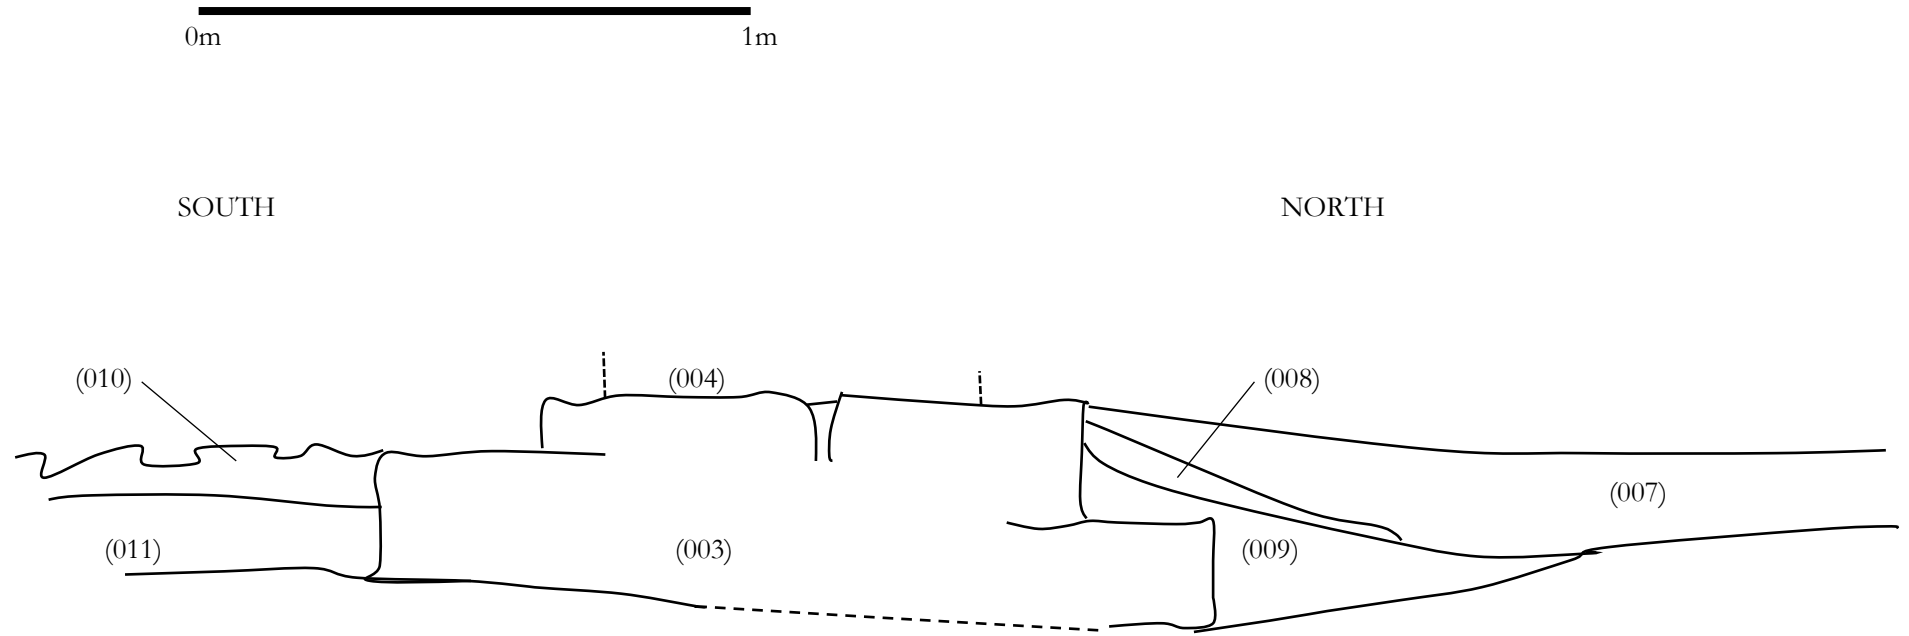
*Figure 8: Section A across North wall near roadside entrance*

There was no obvious cut into the natural subsoil, although the area had been cleaned down to this level so the cut was probably out with the trench. Then, a layer of c500mm large flat stones of c200mm thick was laid, with mortar. Then another course of stone, this time around 300mm/12" thick – both of these are the foundation wall (003). This then formed the base for the upper wall (004), of which just a trace of its base was visible. The concrete slab (005) was made after the walls and surrounding deposits i.e later than everything else.

To the North side of the wall the Natural was overlain by a deep layer of mixed material characteristic of "Trample" – a deposit made by the feet of the tradesmen who made the building, called (009). It had different coloured clays, both yellow and red, patches of dark brown soil, sand, clumps of mortar, all mixed with rounded shingle stones 30-50mm big. Over this lay a deposit of mortar (008) containing little else, which looked to continue along the length of the wall. As this is over the trample it would seem sensible to suggest that it derived from the pointing process after the Church walls had been built. Finally over this was a deep layer of small beach shingle (007), with grains no bigger than 300mm. This extended out beyond the edges of the trench. It was interpreted as the actual path material laid around the building. Over this all was 300-400mm of topsoil and turf (002, 001).

(NAT)-(CUT?)-(003)-(004)-(009)-(008)-(007)-(005)-(002)-(001)

To the south side of the wall, again the foundation stones were lain upon the Natural subsoil. Then a 150mm deep layer of dark brown top soil (011) abutted the stone ie had been deposited against them. On top of that was a compact layer of stone and mortar (010), too uneven to be a floor surface and again interpreted as the mess made when building the structure and plastering the insides. This would imply that the Church had a suspended wooden floor over the top of such deposits.

(NAT)-(CUT?)-(003)-(004)-(011)-(010)-(005)-(002)-(001)
